REPORT CONCERNING THE CAUSE AND CIRCUMSTANCES OF THE FIRE AT VER MEADOWS CARAVAN PARK, REDBOURN, AL3 7RQ ON 12 JULY 2025

HERTFORDSHIRE COUNTY COUNCIL

FILE REFERENCE: 720086

25 JULY 2025

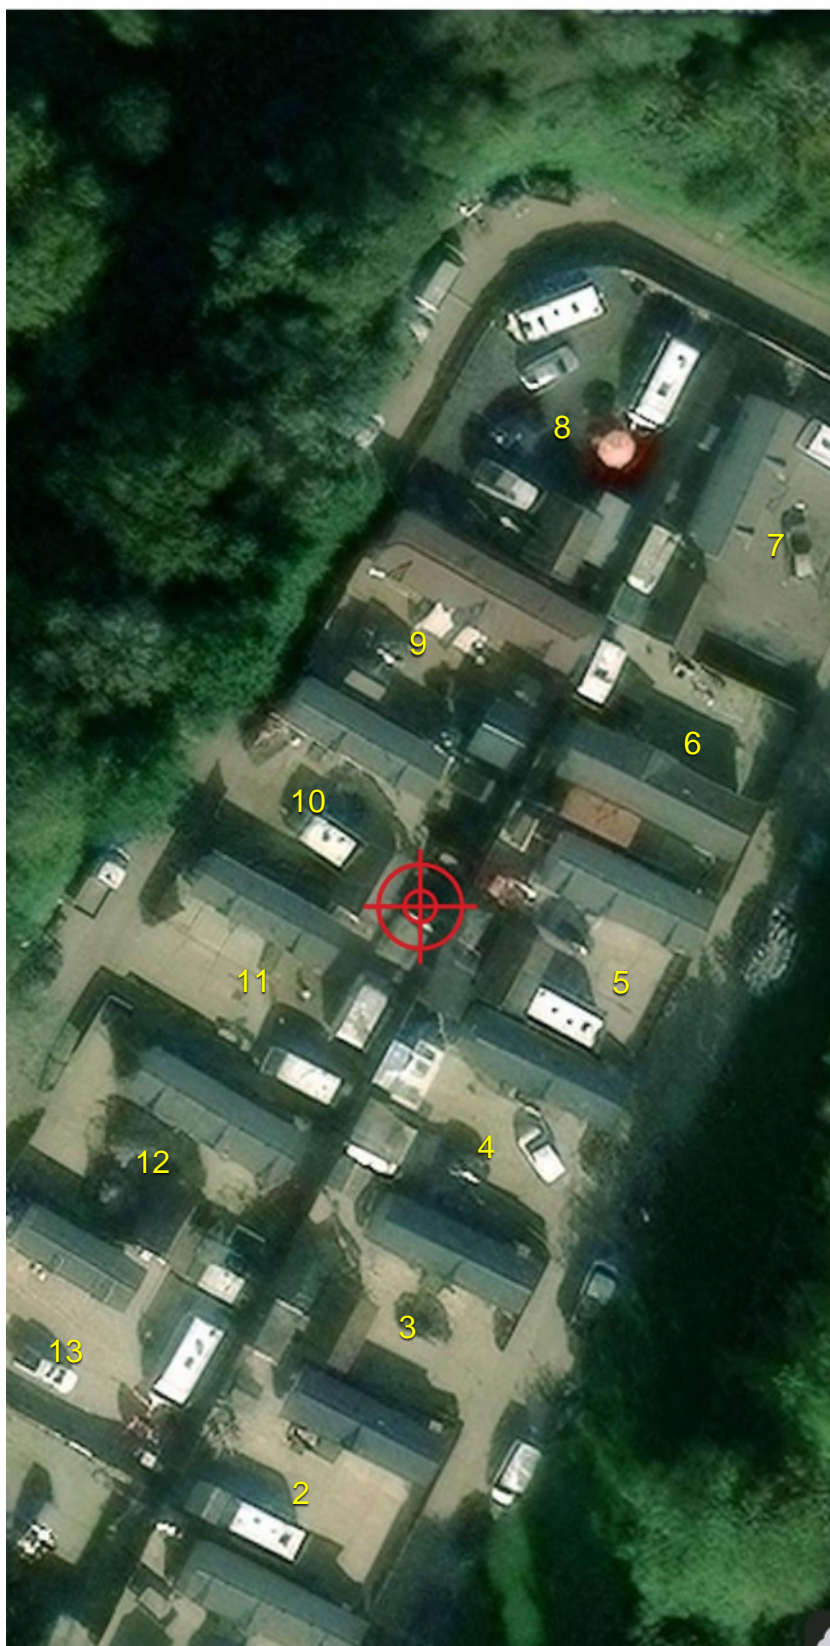
Photograph 6:

On the basis of the statements of fire fighters, and the information obtained from the incident log, it is understood that the first appliances were mobilised at 15.07 hours, and GH11P1 (St Albans) and GH01P1 (Hemel Hempstead) arrived on site within a few seconds of each other at 15.14 and 15.15 hours respectively. There were difficulties getting appliances on to the site owing to the number of vehicles exiting via the only access road. On arrival, it was apparent that there were already multiple caravans involved in the fire. However, on investigation, one firefighter identified an area using *What3words?* where there was a heap of burned and decaying materials (which has been taken to mean a pile of smouldering debris where most of the combustible materials were already exhausted) and most of the surrounding area was on fire. This location corresponds to the corner of plot 10 (see photograph 6) behind the sanitation unit.

A view of the reported location of What3words *jumpy.guides.visa*, which corresponds to plot 10; this is where the fire is believed to have originated.

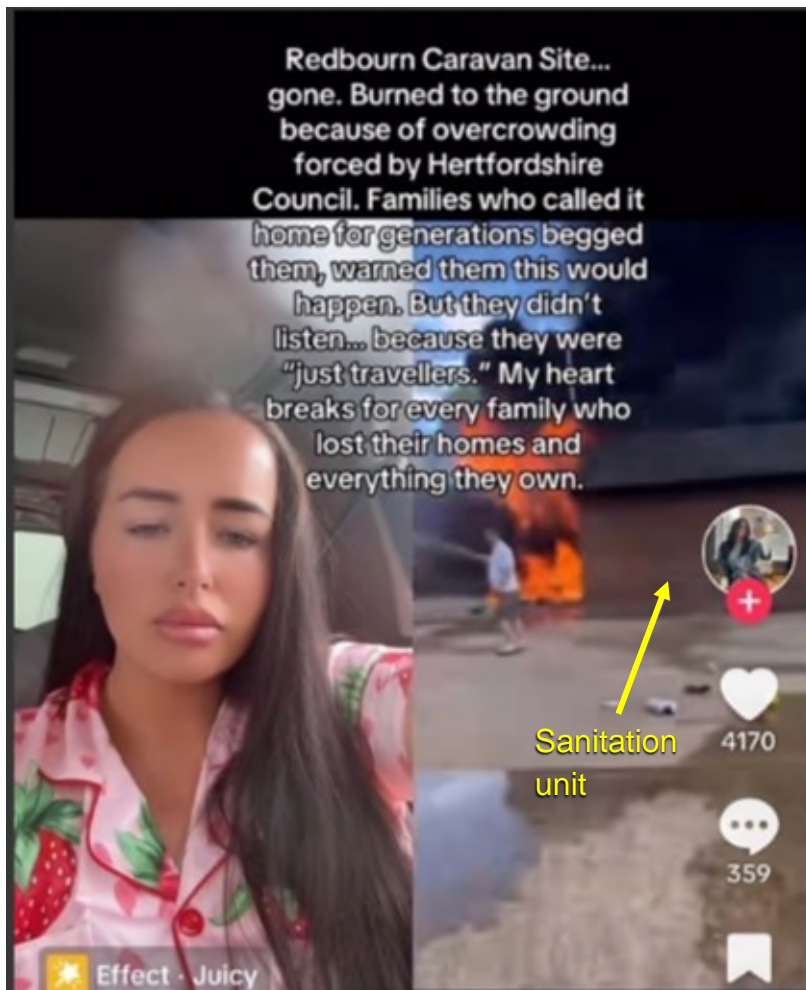
Photograph 7:

A still image reportedly from a social media account has been provided and appears to show the early stages of the fire, but this has not been independently verified. The image appears to show a well-developed fire behind one of the sanitation units (see photograph 7). Based on the scene inspection, it is possible that the photograph shows, but cannot be definitively confirmed as, plot 10 and corresponds to the location of a mobile caravan (see photograph 8).

A screen capture of a social media post which appears to show the fire in progress (annotations are in yellow).

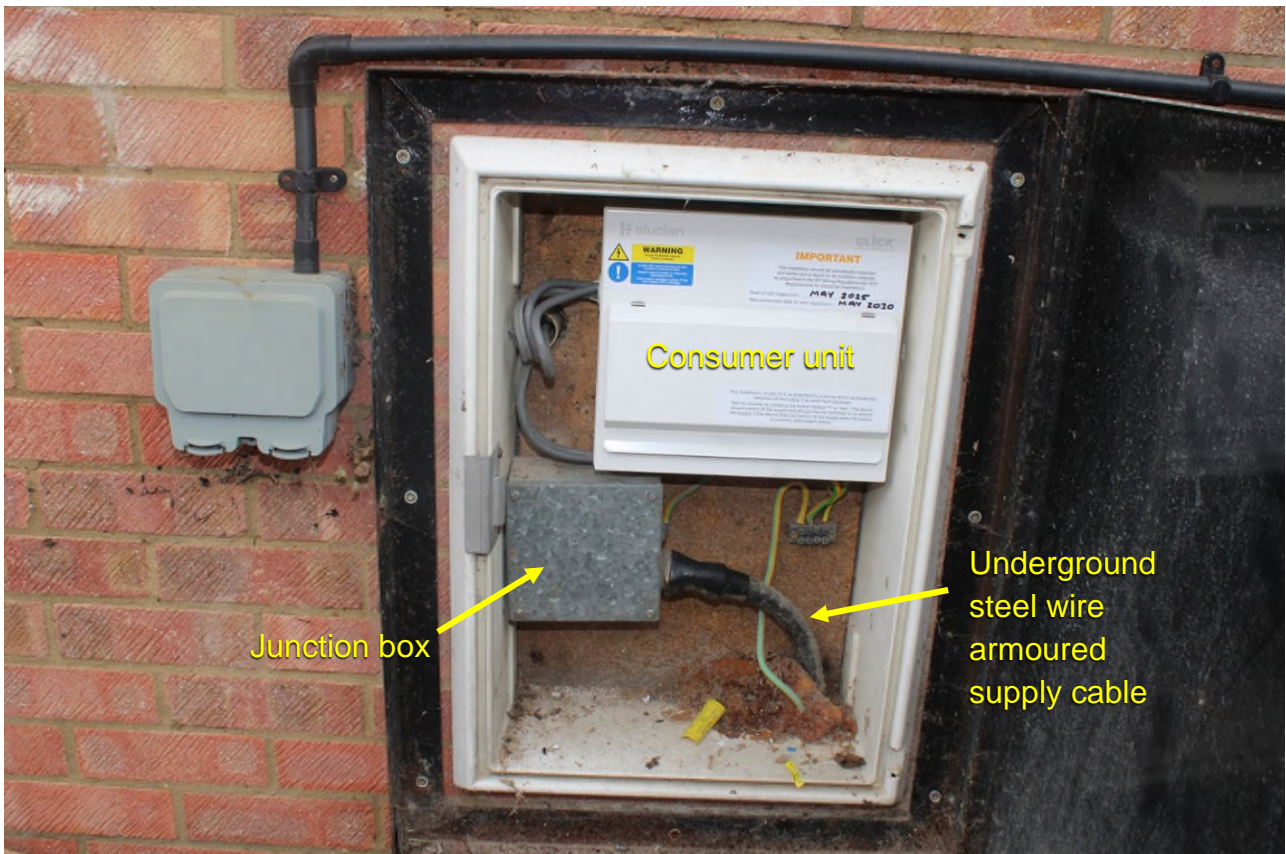
Photograph 9:
A view of the external steel cupboard, showing the key components of the electrical installation.

The consumer unit serving plot 9 (see photographs 9 and 11) was of a modern metal-cased design, and was labelled as having been inspected in May 2025, a couple of months prior to the fire. The installations in plots 6, 8 and 14 all² included similar or the same modern metal clad consumer units which were labelled as having been inspected in May 2025. In addition, many of the other plots, where the external steel cupboards were fire damaged, were served by consumer units of a similar, or the same, design, although any labels to indicate when they had been inspected were destroyed. The consumer unit serving plot 15 was the only one which was found to differ³. However, the consumer unit for plot 15 was undamaged, and there was nothing to suggest that this was associated with the cause of the fire.

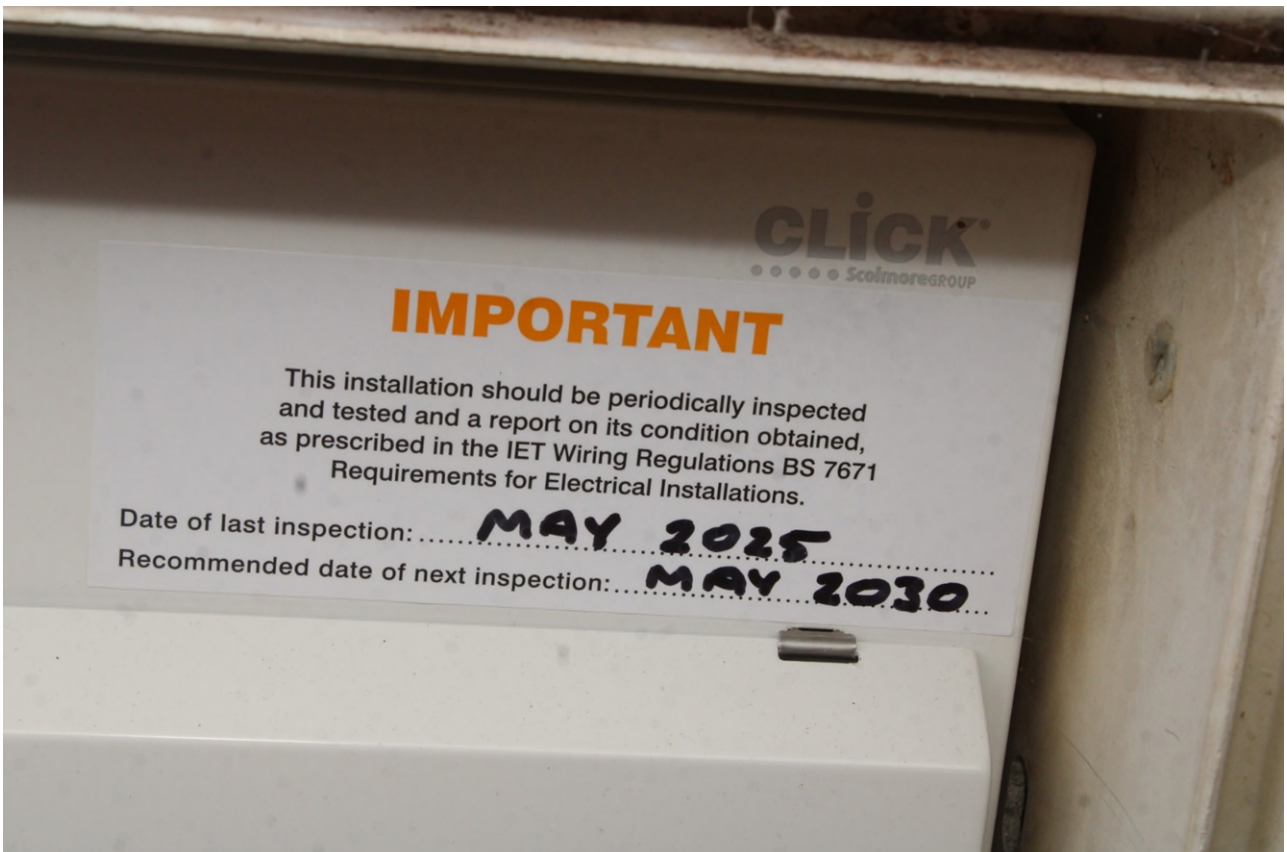
Photograph 11:

The label on the consumer unit serving plot 9 indicating that it was last inspected in May 2025.

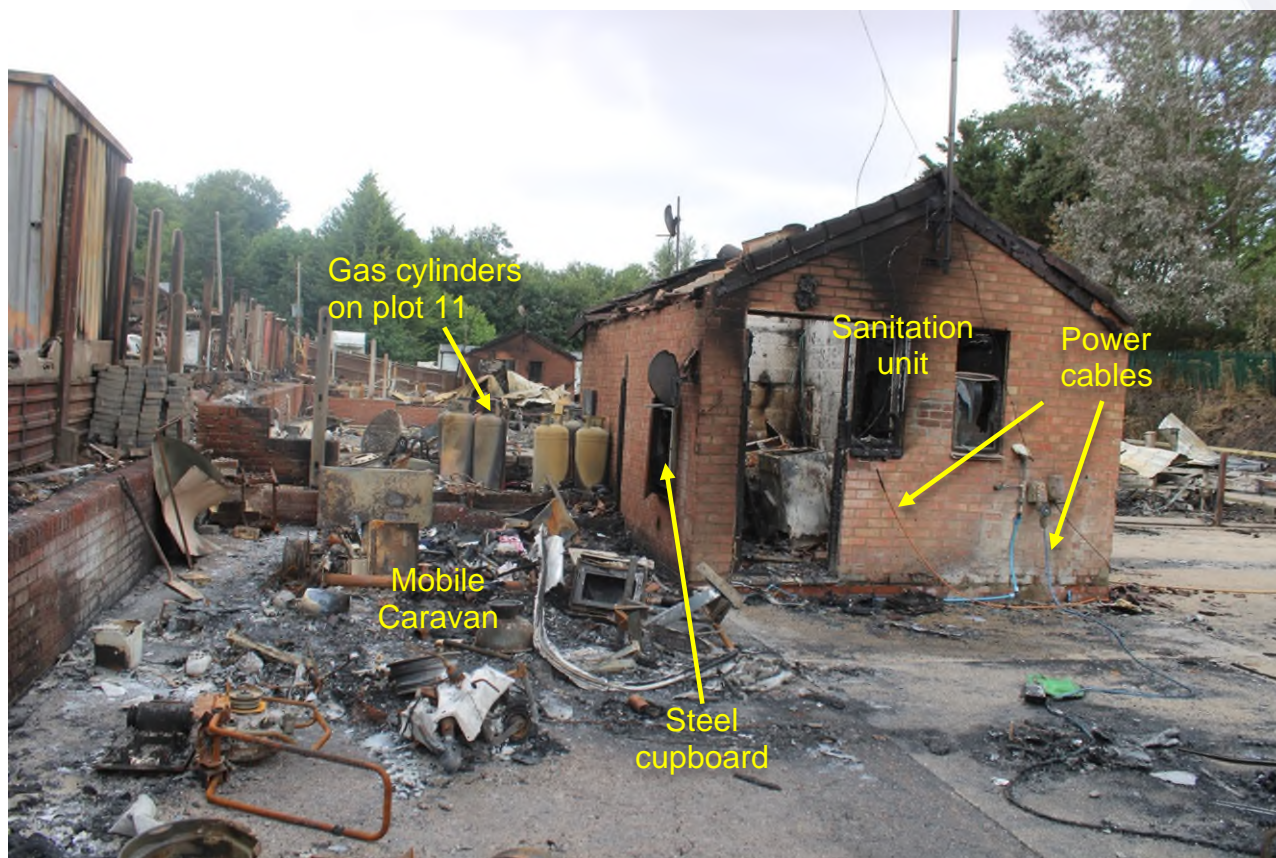
Photograph 12:

Two power cables were routed from the sanitation unit (see photograph 12 and Figure 1). The first, an orange cable was routed away from the mobile caravan and ended at a slightly heat affected waterproof plug found to be loose on the ground. The second power supply was connected to an external waterproof socket on the outside of the sanitation unit and was routed towards the static caravan.

The mobile caravan evidently contained a number of gas appliances, but the nearest gas cylinders were on the neighbouring plot 11, which appeared to have been separated by a fence prior to the fire (see photograph 12 and Figure 1). There were no signs of any gas regulators inserted into those cylinders, and there was no evidence (during the scene inspection or in the Police photographs) of any gas pipes or lines routed from the area of the cylinders (or from anywhere else on plot 10) towards the mobile caravan.

The mobile caravan on plot 10 (left) which was alongside the sanitation unit (right).

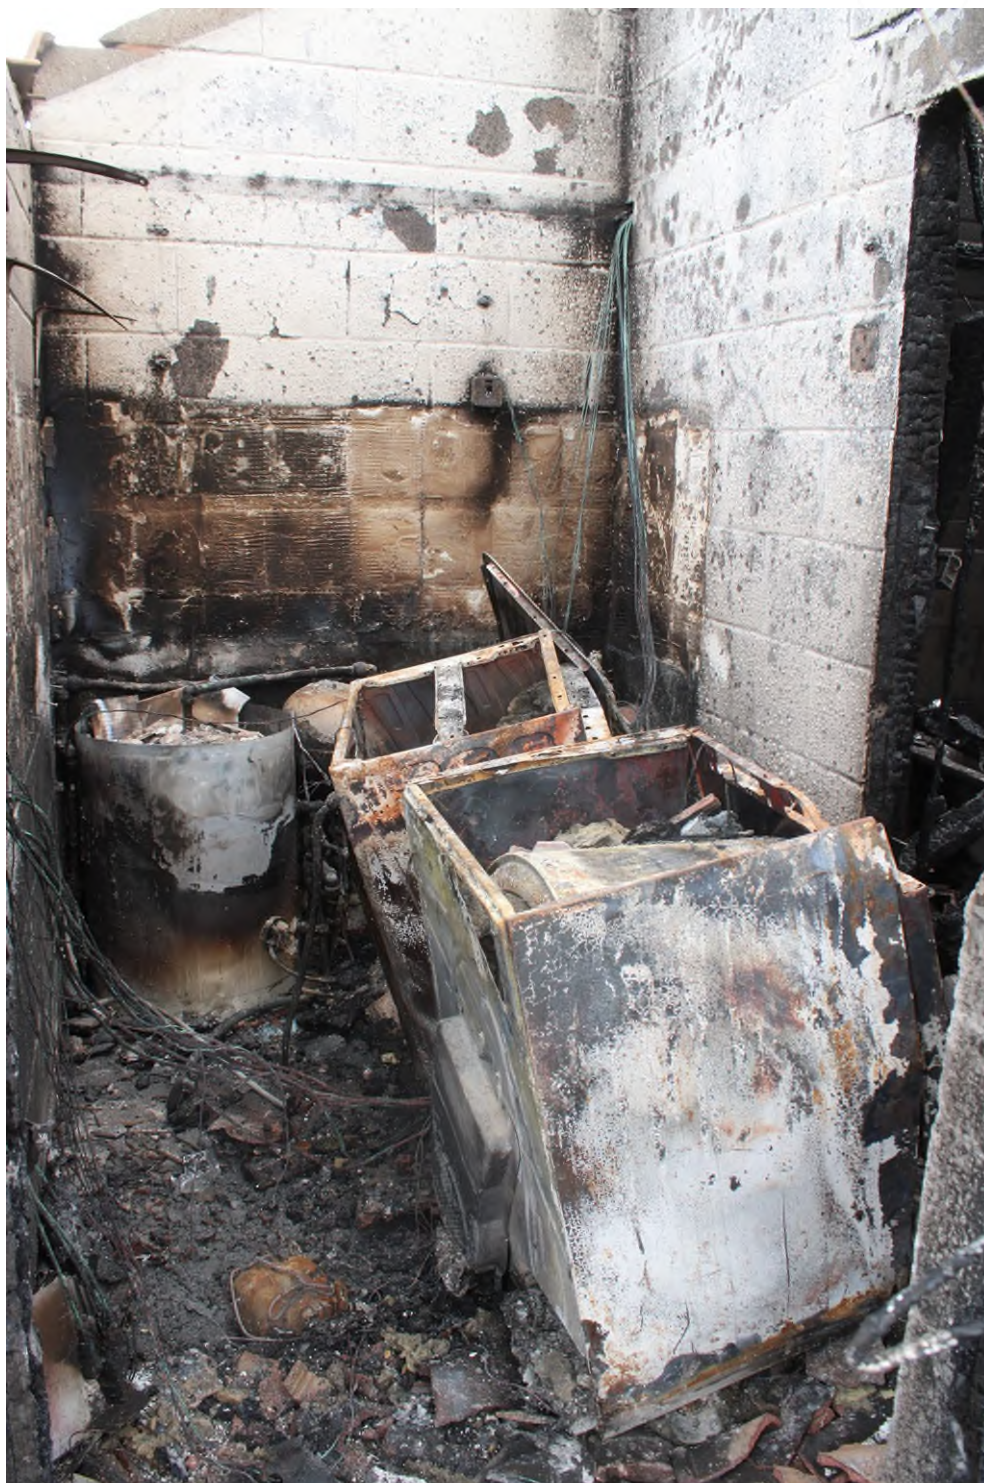
Photograph 13:
A view of the inside of the sanitation unit serving plot 10.

The interior of the sanitation unit was very severely fire damaged, with little combustible material remaining (see photograph 13). Many of the cables forming the fixed wiring inside the building had been destroyed and/or had fragmented as a result of exposure to heat from the fire. There was no evidence of any electrical arcing damage at the limited internal wiring that remained intact. The electricity meter, which had been attached to the wall of the sanitation unit, was largely destroyed, but there was no evidence of any localised heating at the meter terminations (see photograph 14), and no sign of electrical arcing damage at the tails where they were routed within the sanitation unit.

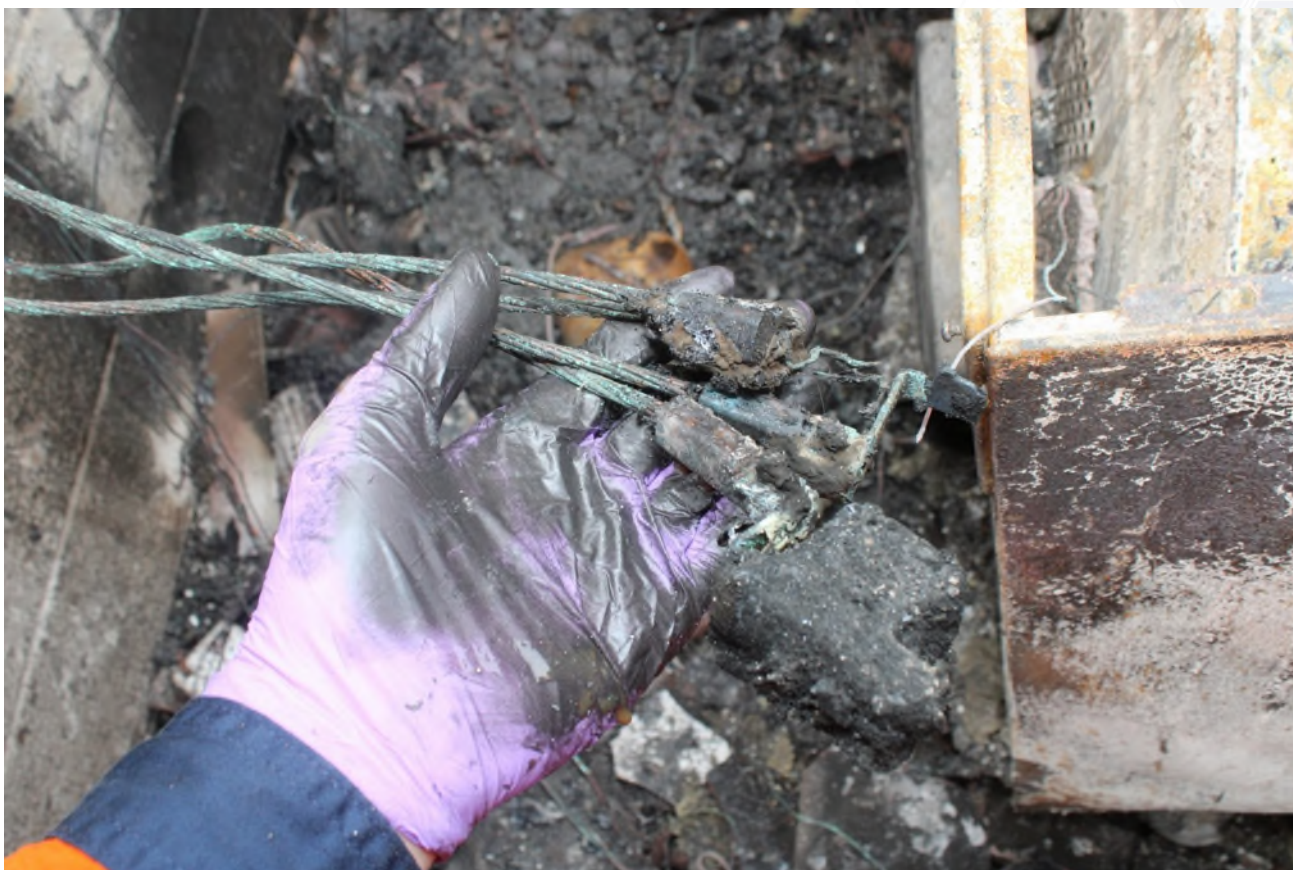
Photograph 14:
The remains of the electricity meter, inside the sanitation unit.

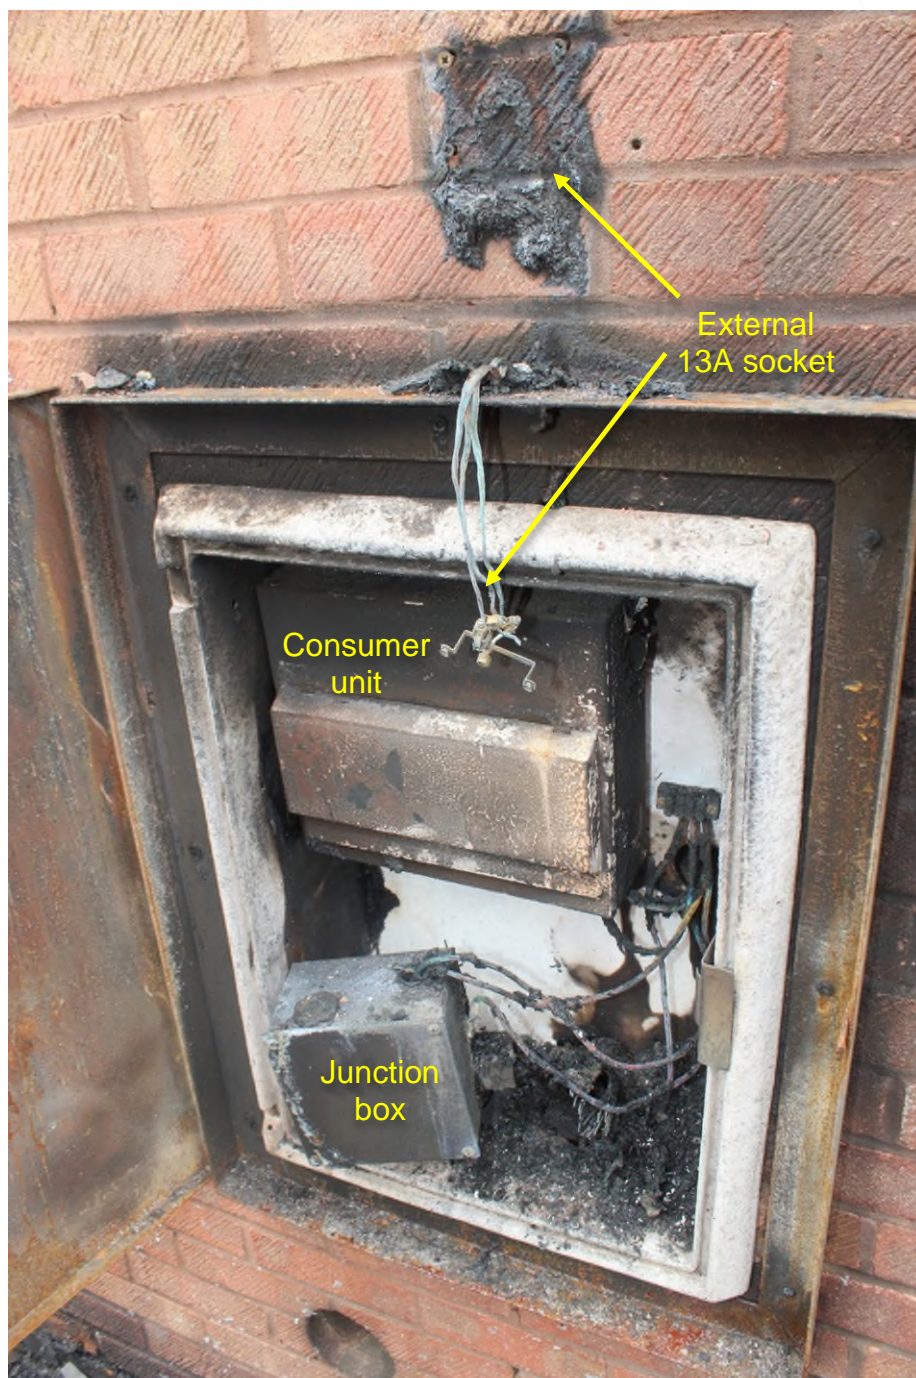
Photograph 15:

Above the external cupboard there was an external 13 A socket which was completely destroyed (see photograph 15). There was no suggestion (during the scene inspection or in the Police photographs) that anything was plugged into the socket, there was no remains of any plug pins

A view of the equipment inside the steel cupboard on the external face of the sanitation unit wall.

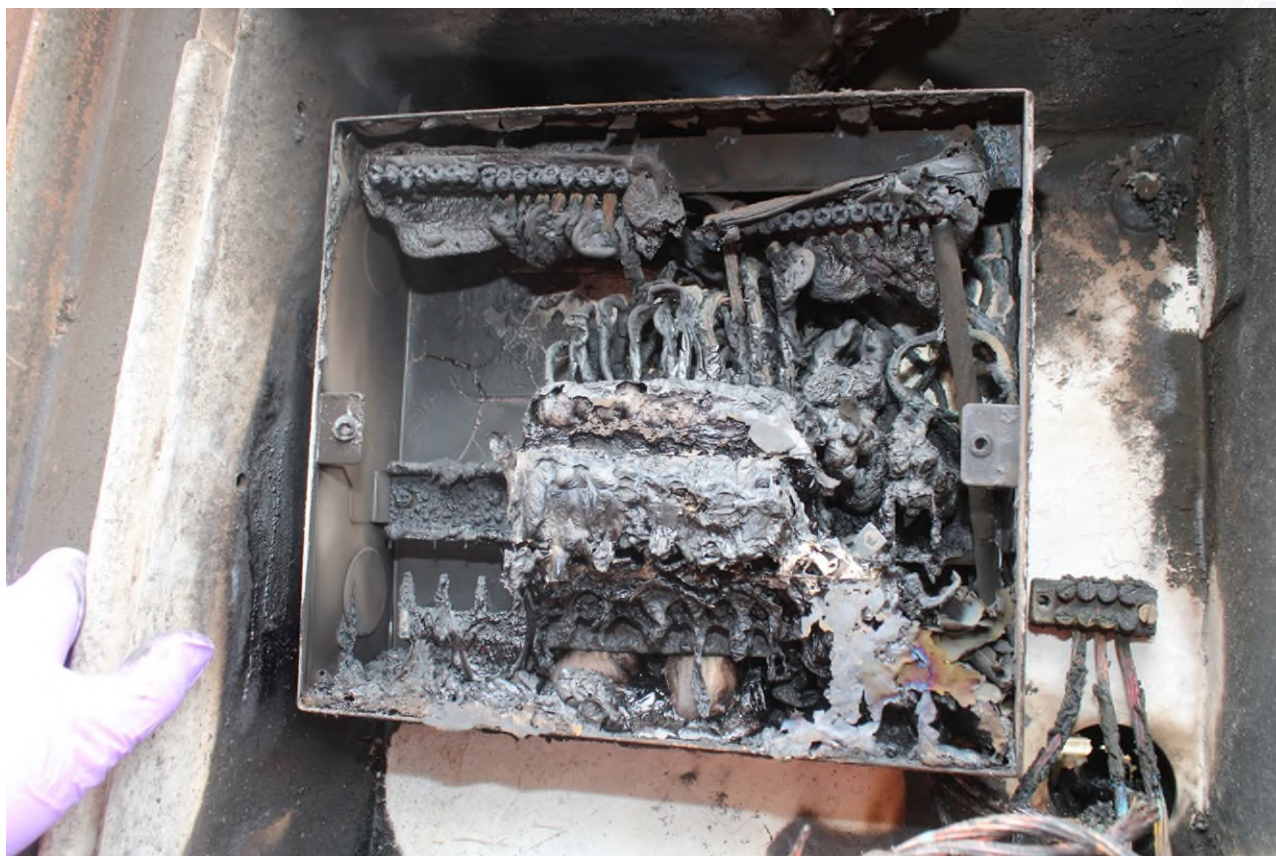
With regard to a fire starting inside the external cupboard, there was no evidence of a causative fault at the junction box and the consumer unit within the cupboard. These items were complete (i.e. none of the components were missing), and the damage to these items can be accounted for by external fire attack. Accordingly the equipment in the external cupboard, which may have been the responsibility of Hertfordshire County Council, can be ruled out as a cause of this fire.

Photograph 16:
A view of the remaining plastic inside the consumer unit.

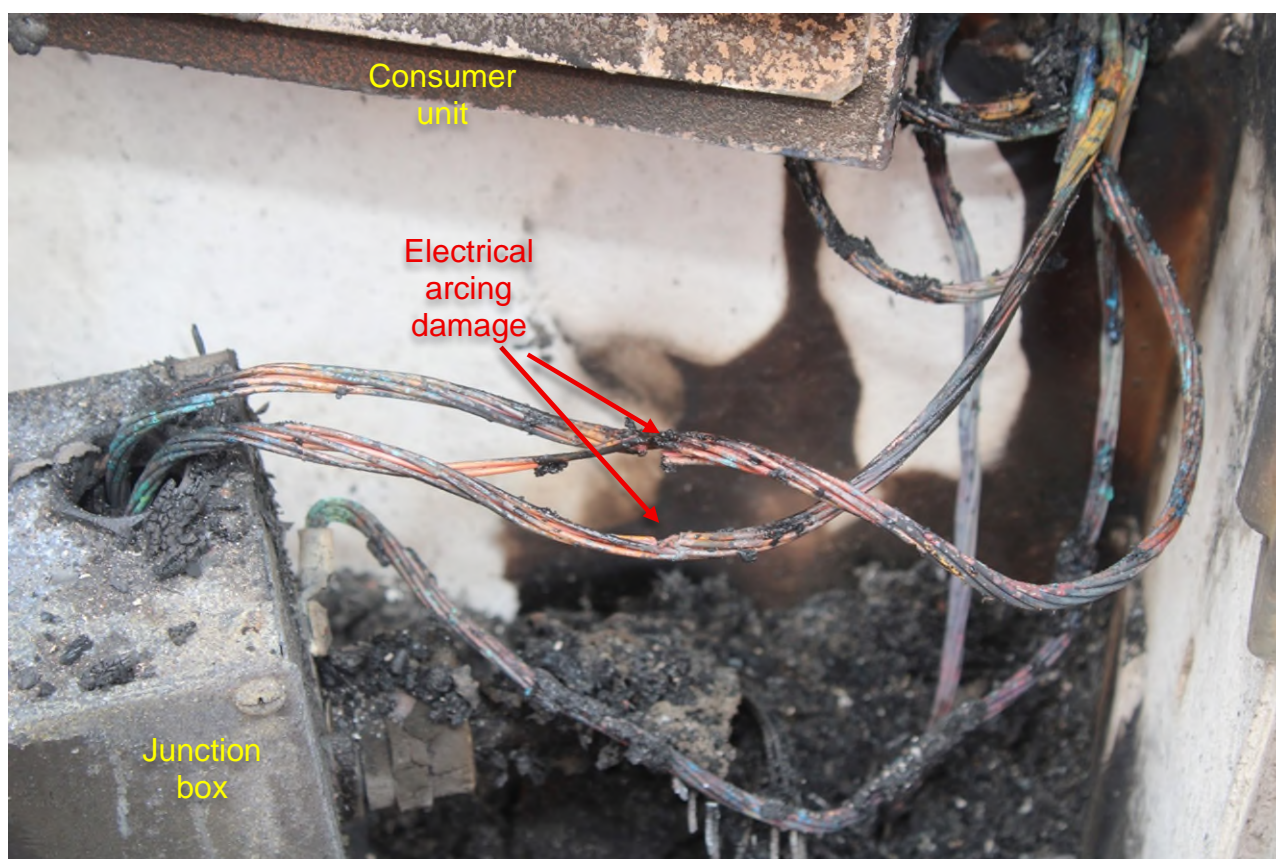
The external steel cupboard serving plot 10 was on the side of the sanitation unit facing towards the mobile caravan as indicated in photograph 12 and Figure 1. The cupboard contained the same equipment as that described above for plot 9, namely a junction box and a modern metal clad consumer unit (see photograph 15). There was no evidence of localised heating at any of the components of the junction box and the consumer unit, both of which contained significant amounts of unburned plastic (see, for example, photograph 16), and had suffered damage consistent with external fire attack. At the tails routed between the junction box and the meter, there was electrical arcing damage a short distance from the junction box (see photograph 17).

There was no remaining pattern of damage to the caravan park to indicate the area of origin of this fire. However, electrical arcing damage, such as that found on the meter tails inside the steel cupboard on the outside of the sanitation unit, can provide evidence for the area of origin of a fire.

In this case the electrical arcing damage had occurred at meter tails within the external steel cupboard, rather than inside the sanitation unit close to the meter. The short circuit fault current had likely resulted in the operation of a 60 A circuit breaker at the main distribution board in the warden's building. This evidence indicates that the external meter cupboard was subject to fire attack or radiant heat before a fire developed within the sanitation unit. This is most readily explained by either a fire developing within the external cupboard, or a fire at or in the area of the mobile caravan.

Photograph 17:
A view of the electrical arcing damage a short distance from the junction box.

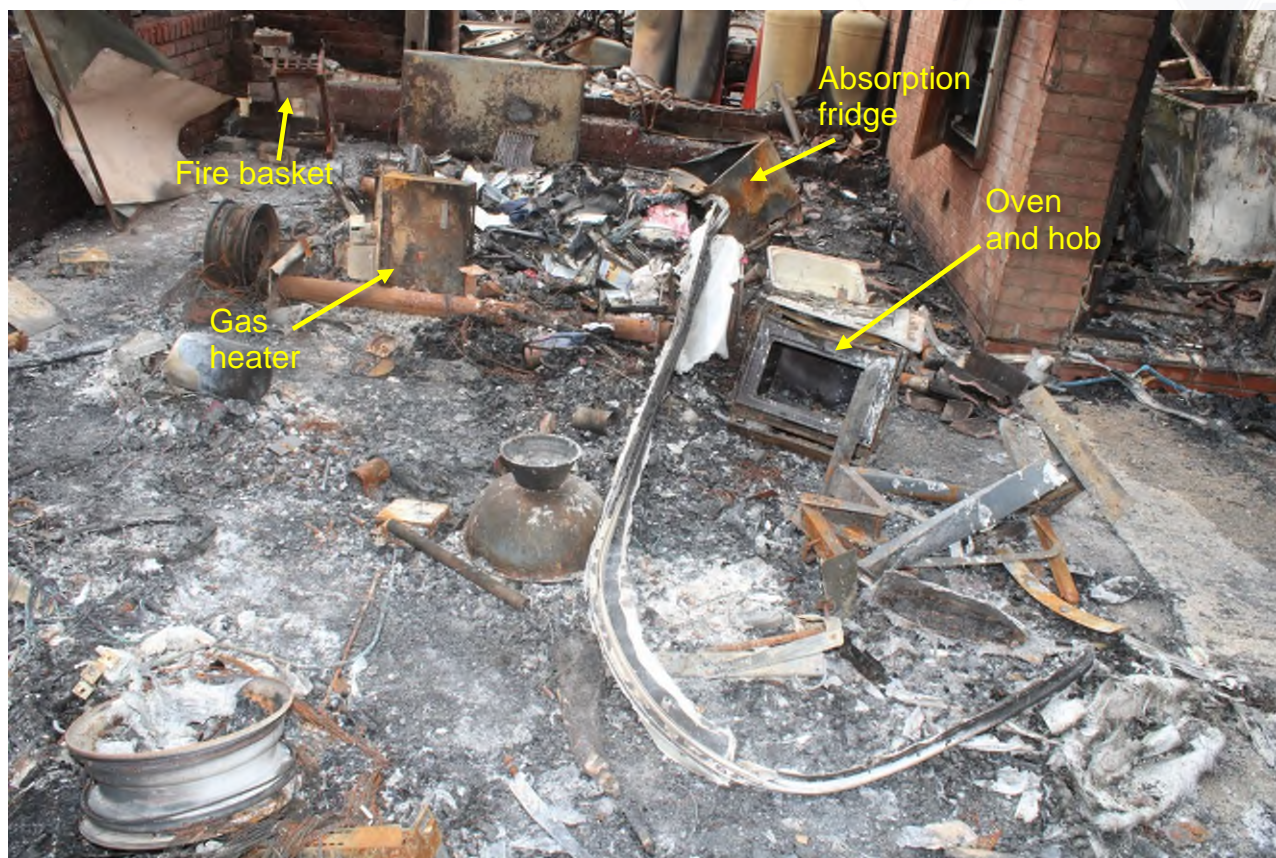
Photograph 18:

Appliances in the mobile caravan included an absorption fridge, a conventional electric fridge or freezer, a gas oven and hob, and a gas heater (see photograph 18). All the appliances had sustained very severe fire damage and, in general, they yielded no useful evidence. However, the oven did not appear to contain any food at the time of the fire (although given the extent of the damage, any such evidence may have been lost) and the controls for the hob rings all appeared to be in the same position, which was presumably *off*. Moreover, on the basis of the absence of any power or gas supply lines being routed to the caravan, none of the appliances were powered/fuelled at the material time.

In considering the possible causes within the mobile caravan, there is no evidence to suggest that the caravan had a live power supply or gas supply at the material time and, on this basis, the fire was not caused by a fault at an energised electrical appliance or a faulty gas appliance / ignition of a gas leak.

A view of a selection of the appliances in the mobile caravan.
