## REPORT CONCERNING THE CAUSE AND CIRCUMSTANCES OF THE FIRE AT VER MEADOWS CARAVAN PARK, REDBOURN, AL3 7RQ ON 12 JULY 2025

HERTFORDSHIRE COUNTY COUNCIL

FILE REFERENCE: 720086

1 AUGUST 2025

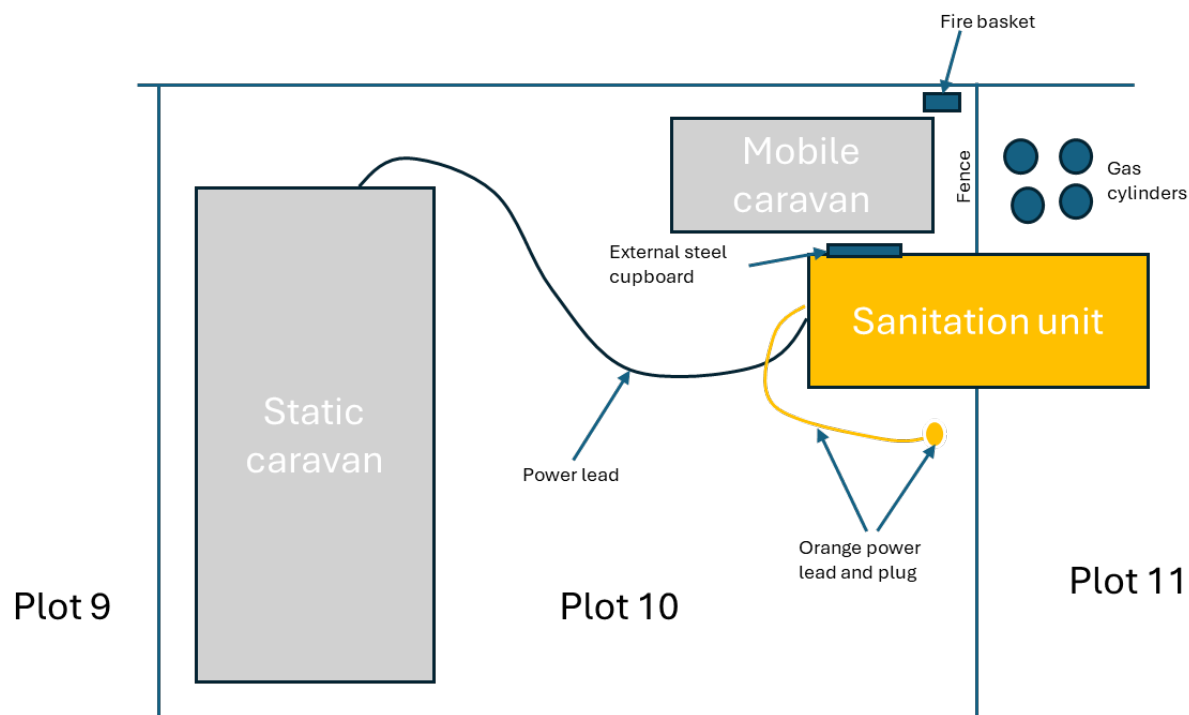
**FIGURE 1**  
A schematic plan of plot 10

Two power cables were routed from the sanitation unit (see photograph 12 and Figure 1). The first, an orange cable was routed away from the mobile caravan and ended at a slightly heat affected waterproof plug found to be loose on the ground. The second power supply was connected to an external waterproof socket on the outside of the sanitation unit and was routed towards the static caravan.

The external steel cupboard serving plot 10 was on the side of the sanitation unit facing towards the mobile caravan as indicated in photograph 12 and Figure 1. The cupboard contained the same equipment as that described above for plot 9, namely a junction box and a modern metal clad consumer unit (see photograph 15). There was no evidence of localised heating at any of the components of the junction box and the consumer unit, both of which contained significant amounts of unburned plastic (see, for example, photograph 16), and had suffered damage consistent with external fire attack. At the tails routed between the junction box and the meter, there was electrical arcing damage a short distance from the junction box (see photograph 17).

The mobile caravan evidently contained a number of gas appliances, but the nearest gas cylinders were on the neighbouring plot 11, which appeared to have been separated by a fence prior to the fire (see photograph 12 and Figure 1). There were no signs of any gas regulators inserted into those cylinders, and there was no evidence (during the scene inspection or in the Police photographs) of any gas pipes or lines routed from the area of the cylinders (or from anywhere else on plot 10) towards the mobile caravan.

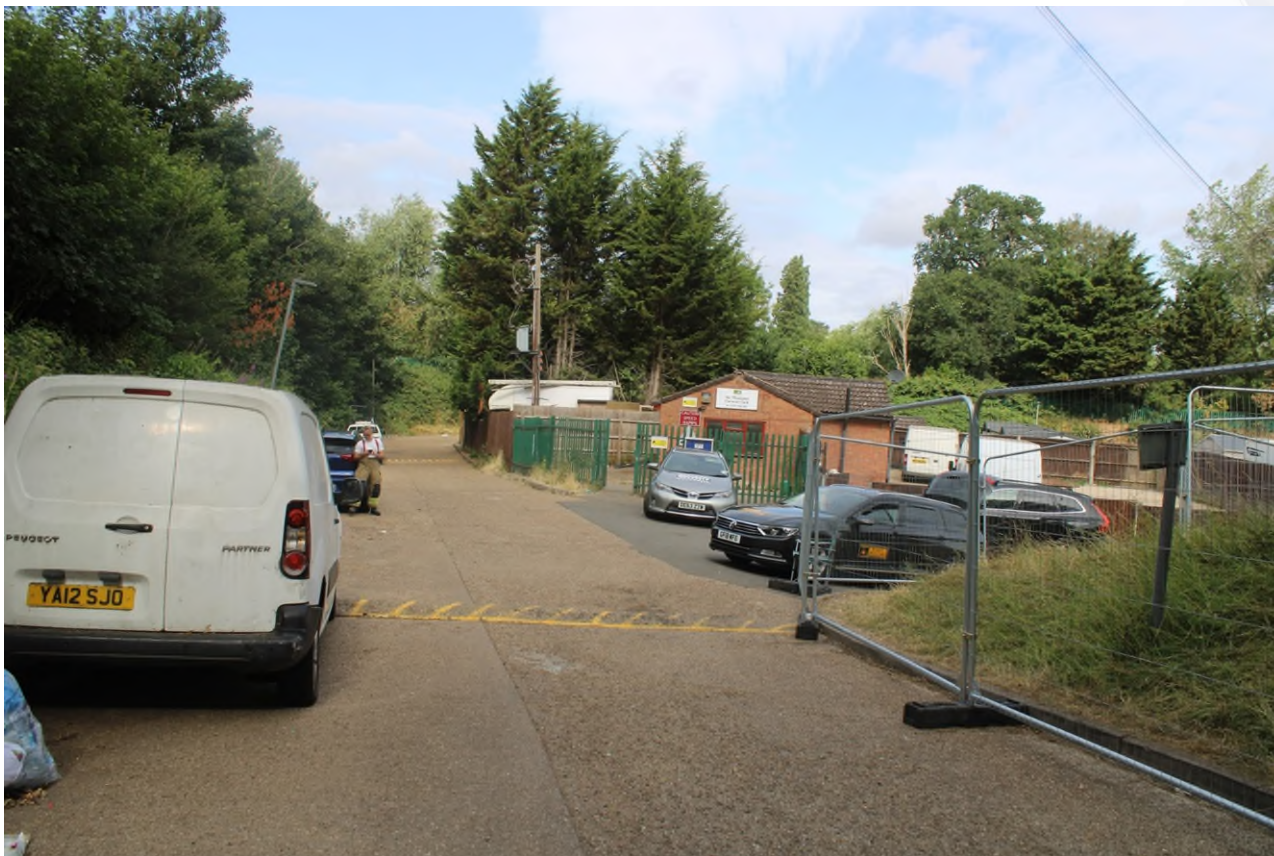
**Photograph 1:**

Ver Meadows Caravan Park was a travellers' site comprising fifteen plots, and a warden's building (see photographs 1-5). The plots were served by sanitation units (each sanitation unit generally served two plots) comprising small brick constructions with laundry and bathroom facilities. The power and water to each plot were also supplied *via* the sanitation units, as discussed in more detail below.

A view from the main entrance to Ver Meadows Caravan Park showing the warden's building.

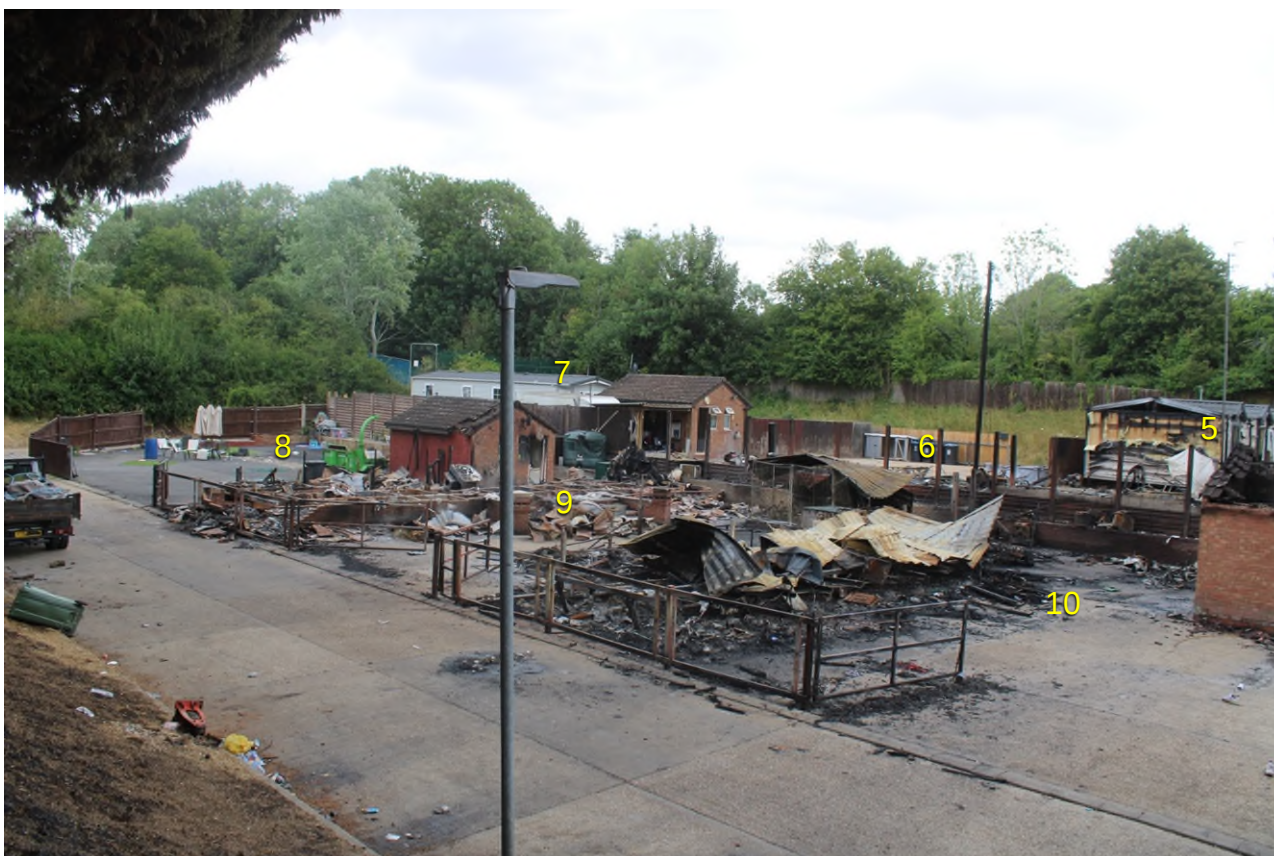
**Photograph 2:**

At the time of inspection, the warden's building was undamaged, and plots 1 and 8 contained no caravans (the caravans from plot 8 had been removed after the fire and it is uncertain whether there were any caravans on plot 1 at the time of the fire). Vehicles and caravans on plots 7 and 15 had largely escaped serious fire damage. Static caravans on plots 2, 5 and 14 had sustained varying degrees of radiant heat damage. One or more caravans on plots 3, 4, 5, 6, 9, 10, 11, 12 and 13 and their contents were effectively destroyed (see photographs 2-5).

A view towards the north end of the site (the plot numbers are indicated in yellow).

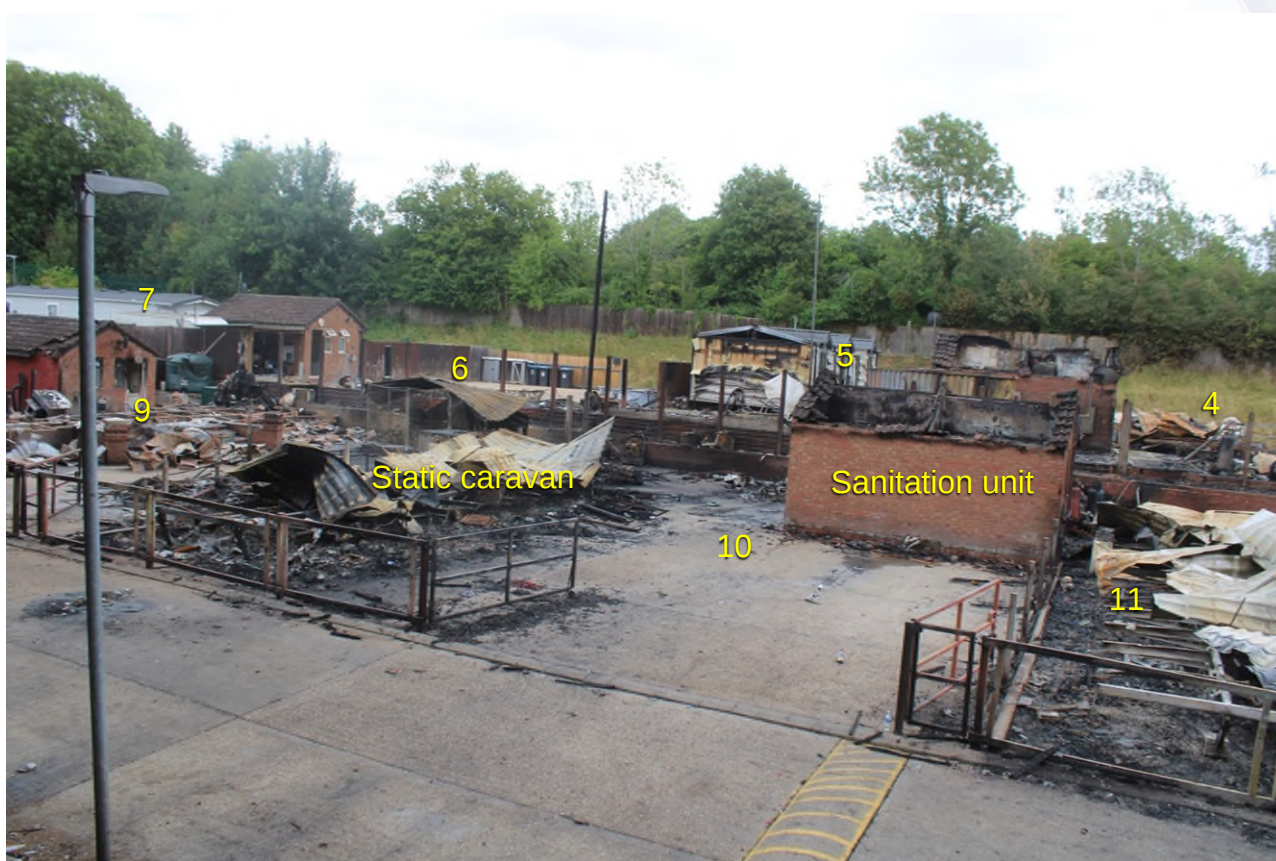
**Photograph 3:**  
A view of plot 10 and the surrounding area.

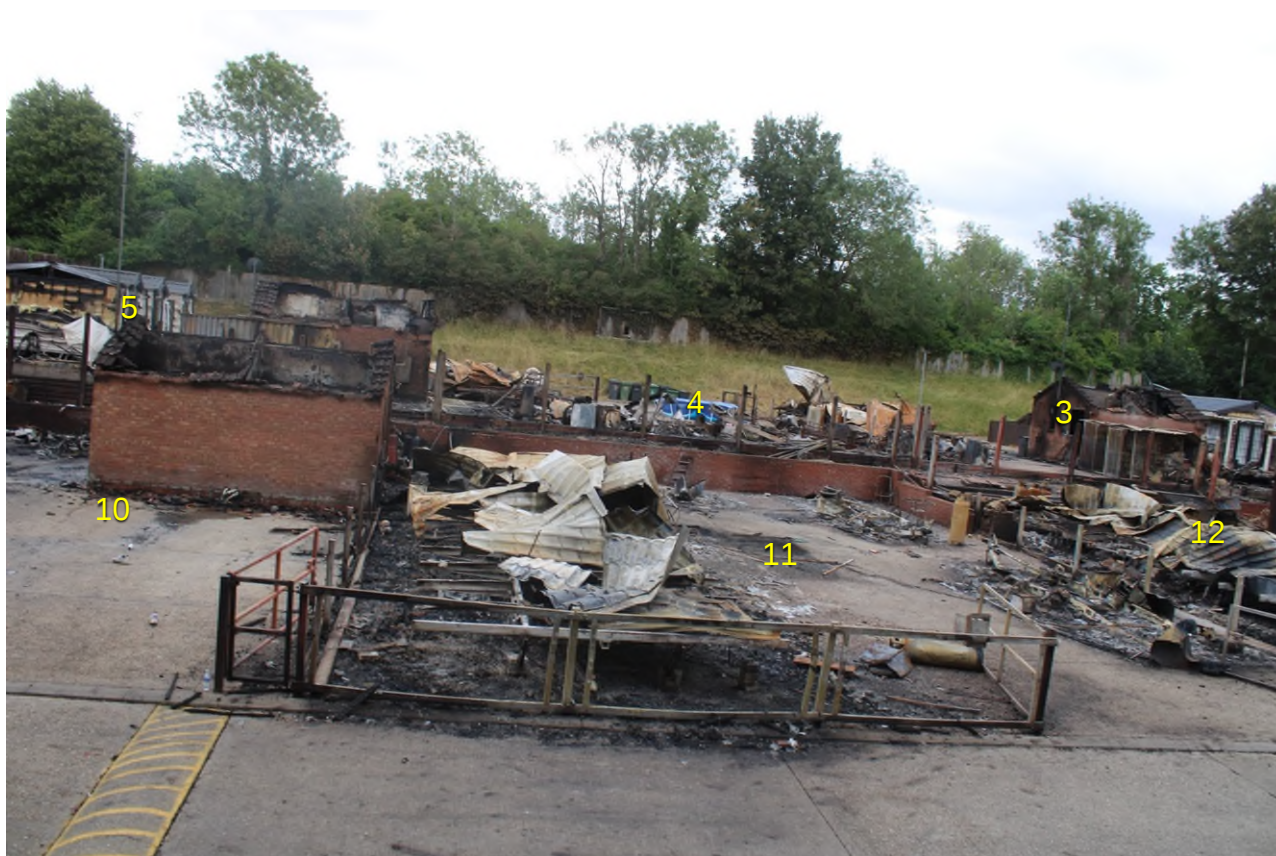
**Photograph 4:**  
A view of plot 11 and the surrounding area.

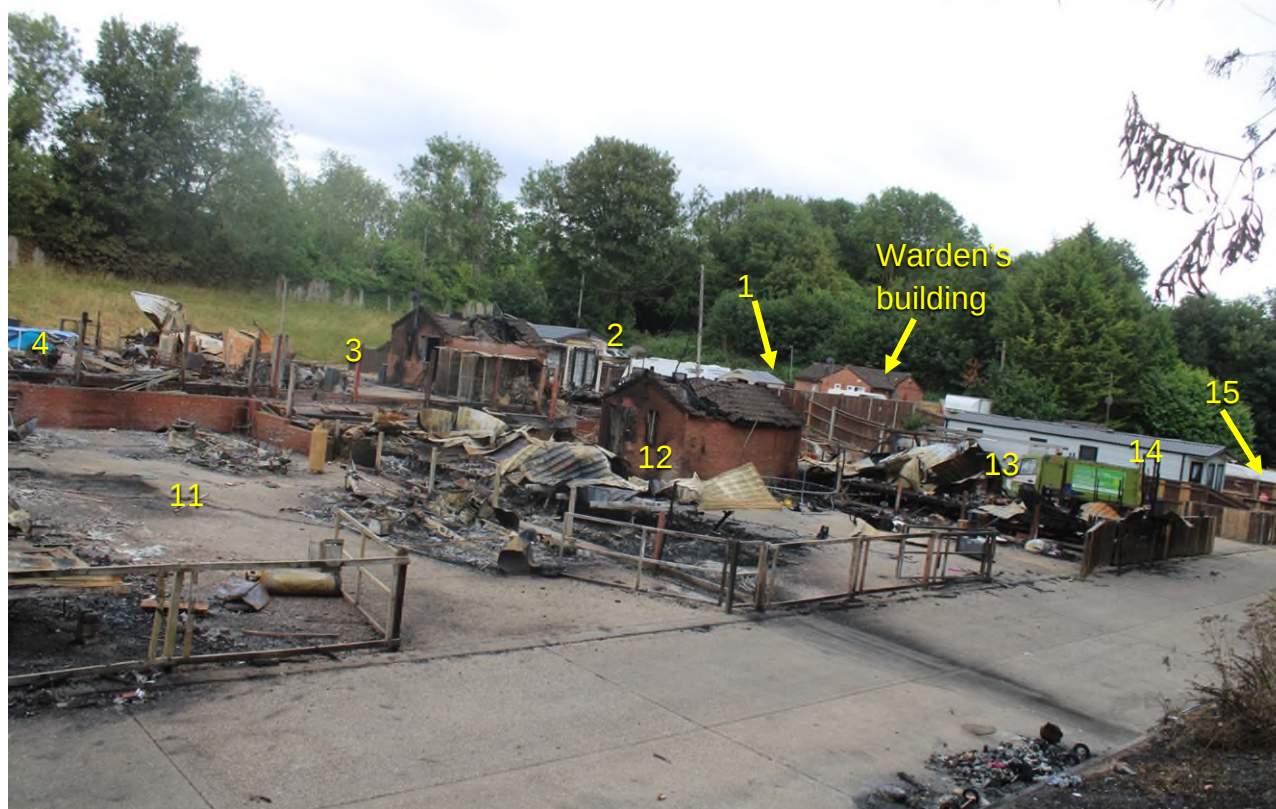
**Photograph 5:**  
A view of the south end of the site.

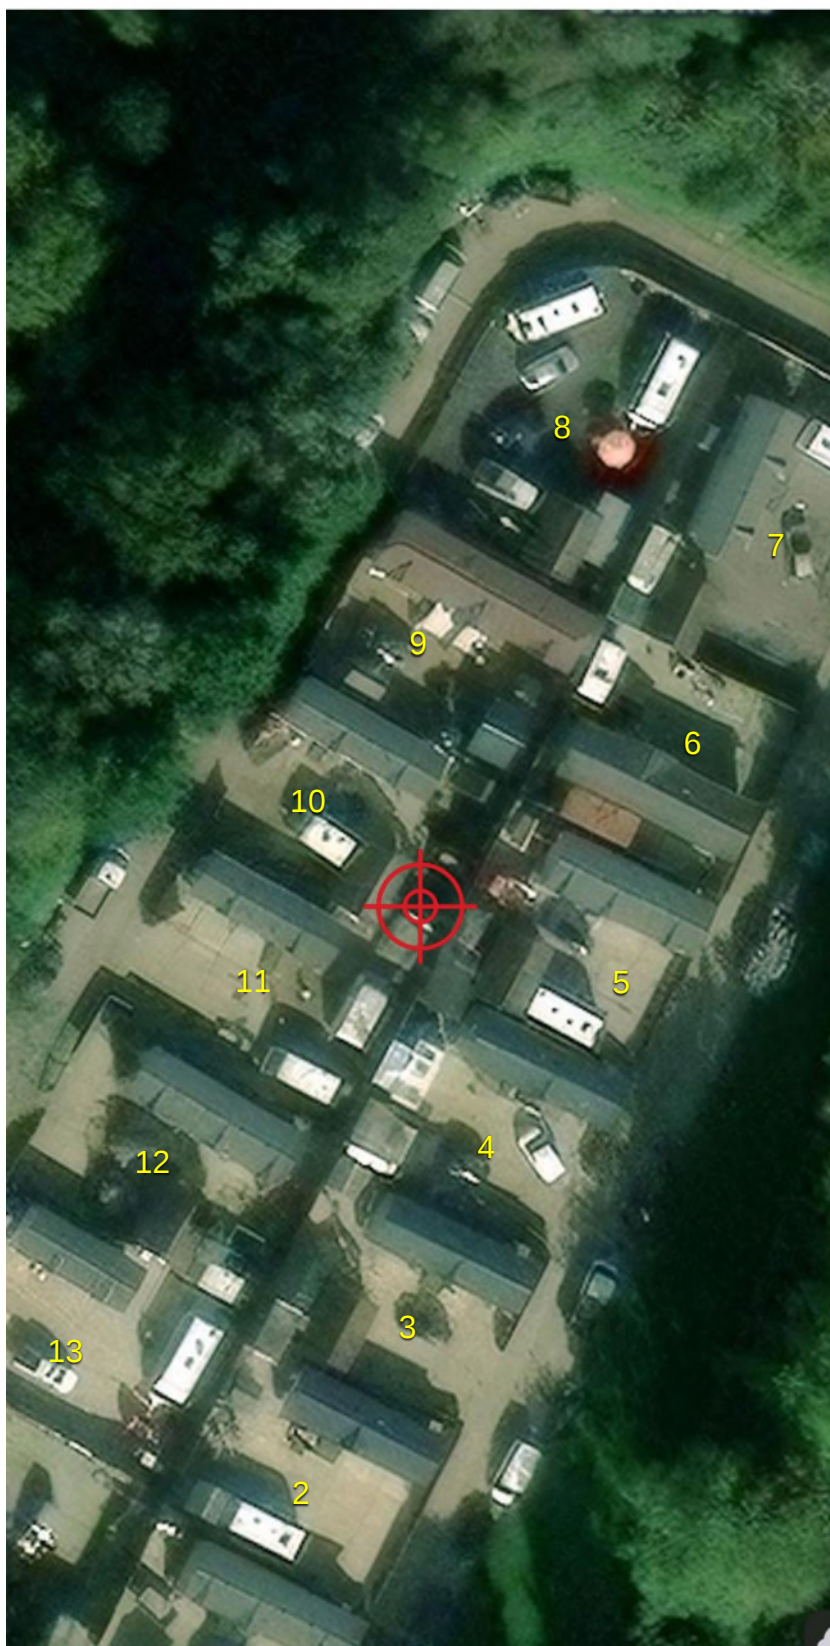
**Photograph 6:**

On the basis of the statements of fire fighters, and the information obtained from the incident log, it is understood that the first appliances were mobilised at 15.07 hours, and GH11P1 (St Albans) and GH01P1 (Hemel Hempstead) arrived on site within a few seconds of each other at 15.14 and 15.15 hours respectively. There were difficulties getting appliances on to the site owing to the number of vehicles exiting via the only access road. On arrival, it was apparent that there were already multiple caravans involved in the fire. However, on investigation, one firefighter identified an area using *What3words?* where there was a heap of burned and decaying materials (which has been taken to mean a pile of smouldering debris where most of the combustible materials were already exhausted) and most of the surrounding area was on fire. This location corresponds to the corner of plot 10 (see photograph 6) behind the sanitation unit.

A view of the reported location of What3words *jumpy.guides.visa*, which corresponds to plot 10; this is where the fire is believed to have originated.

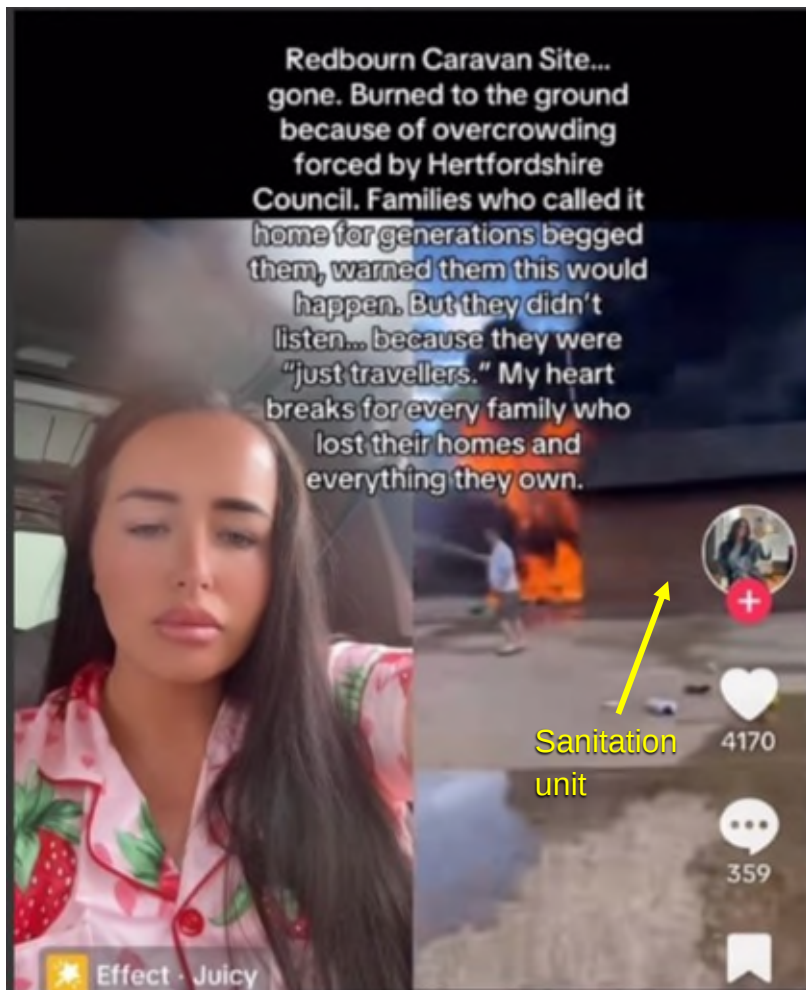
**Photograph 7:**

A still image reportedly from a social media account has been provided and appears to show the early stages of the fire, but this has not been independently verified. The image appears to show

a well-developed fire behind one of the sanitation units (see photograph 7). Based on the scene inspection, it is possible that the photograph shows, but cannot be definitively confirmed as, plot 10 and corresponds to the location of a mobile caravan (see photograph 8).

A screen capture of a social media post which appears to show the fire in progress (annotations are in yellow).

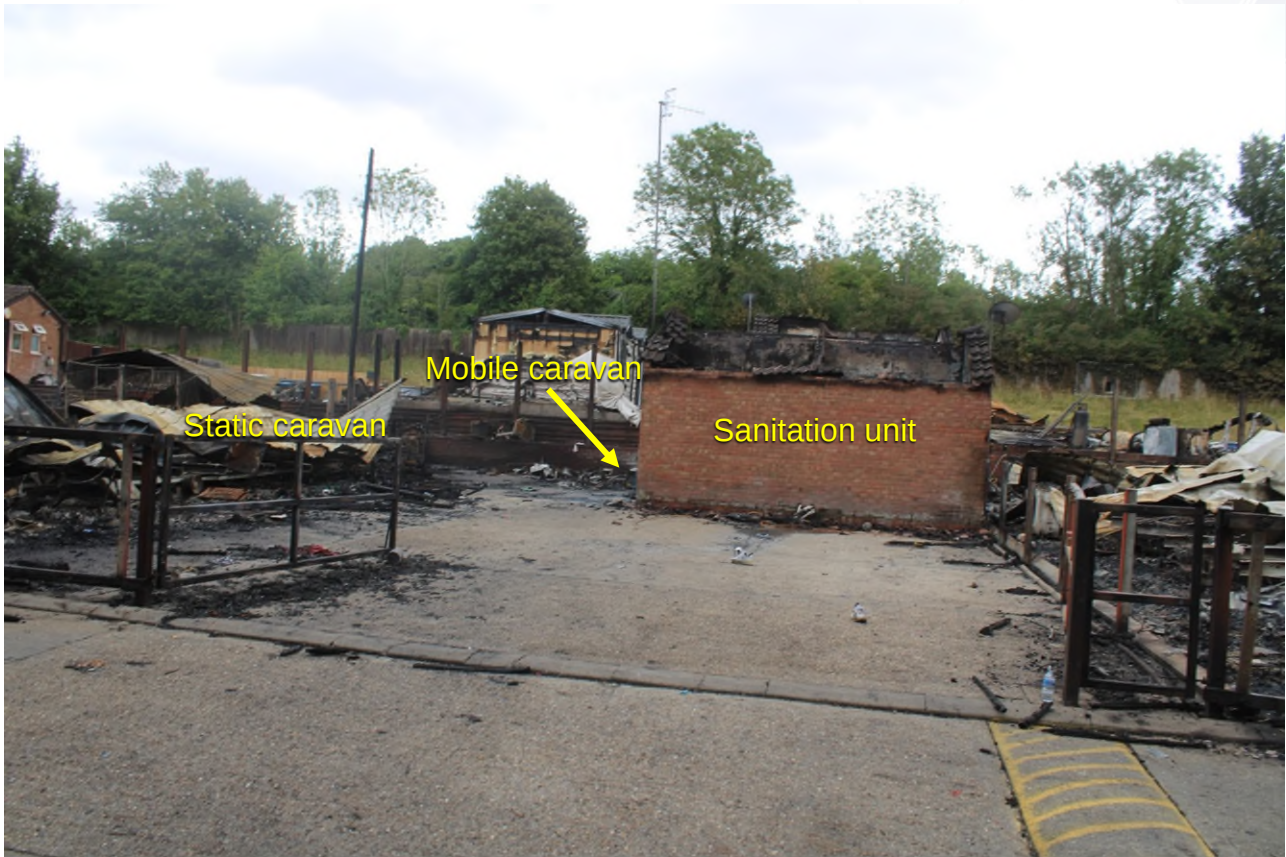
**Photograph 8:**  
A view of plot 10 from the access road.

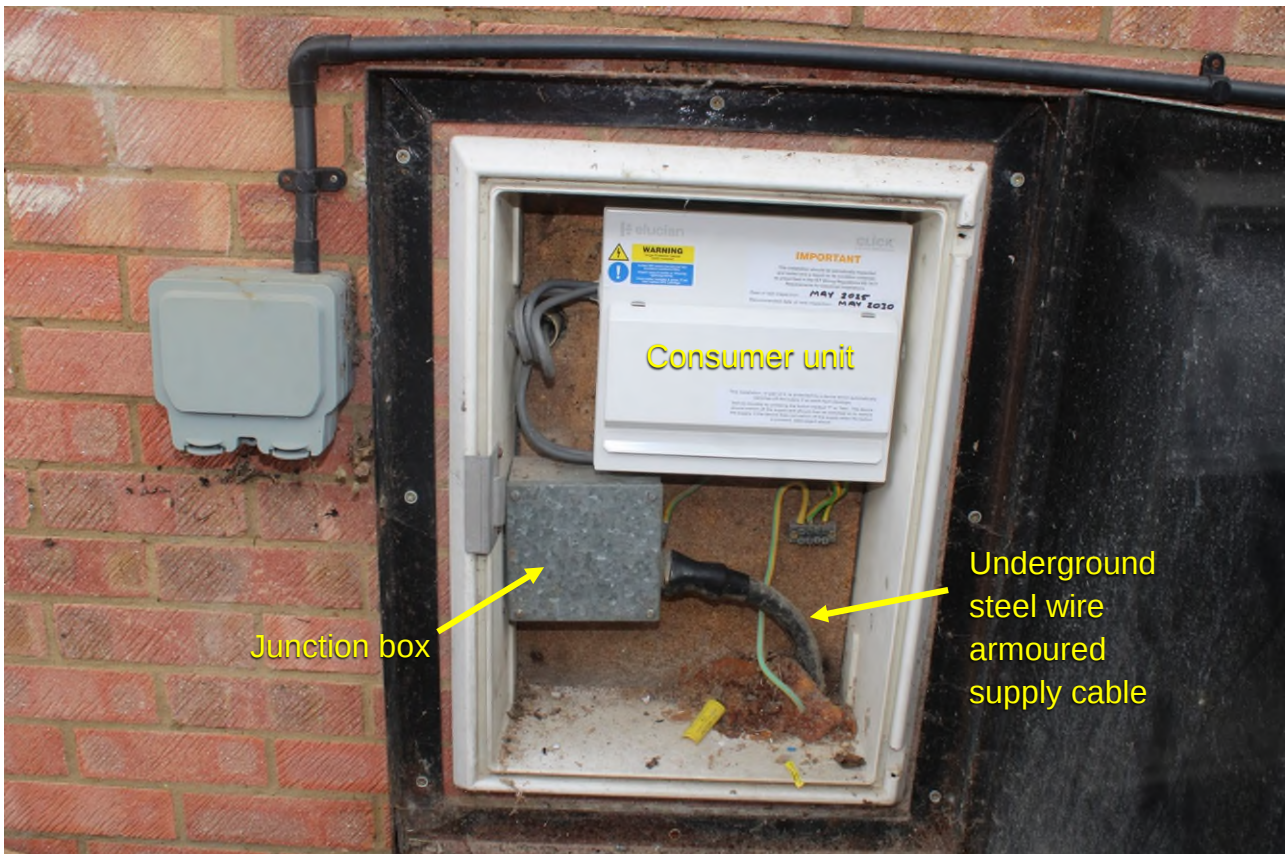
The consumer unit serving plot 9 (see photographs 9 and 11) was of a modern metal-cased design, and was labelled as having been inspected in May 2025, a couple of months prior to the fire. The installations in plots 6, 8 and 14 all<sup>2</sup> included similar or the same modern metal clad

**Photograph 9:**  
A view of the external steel cupboard, showing the key components of the electrical installation.

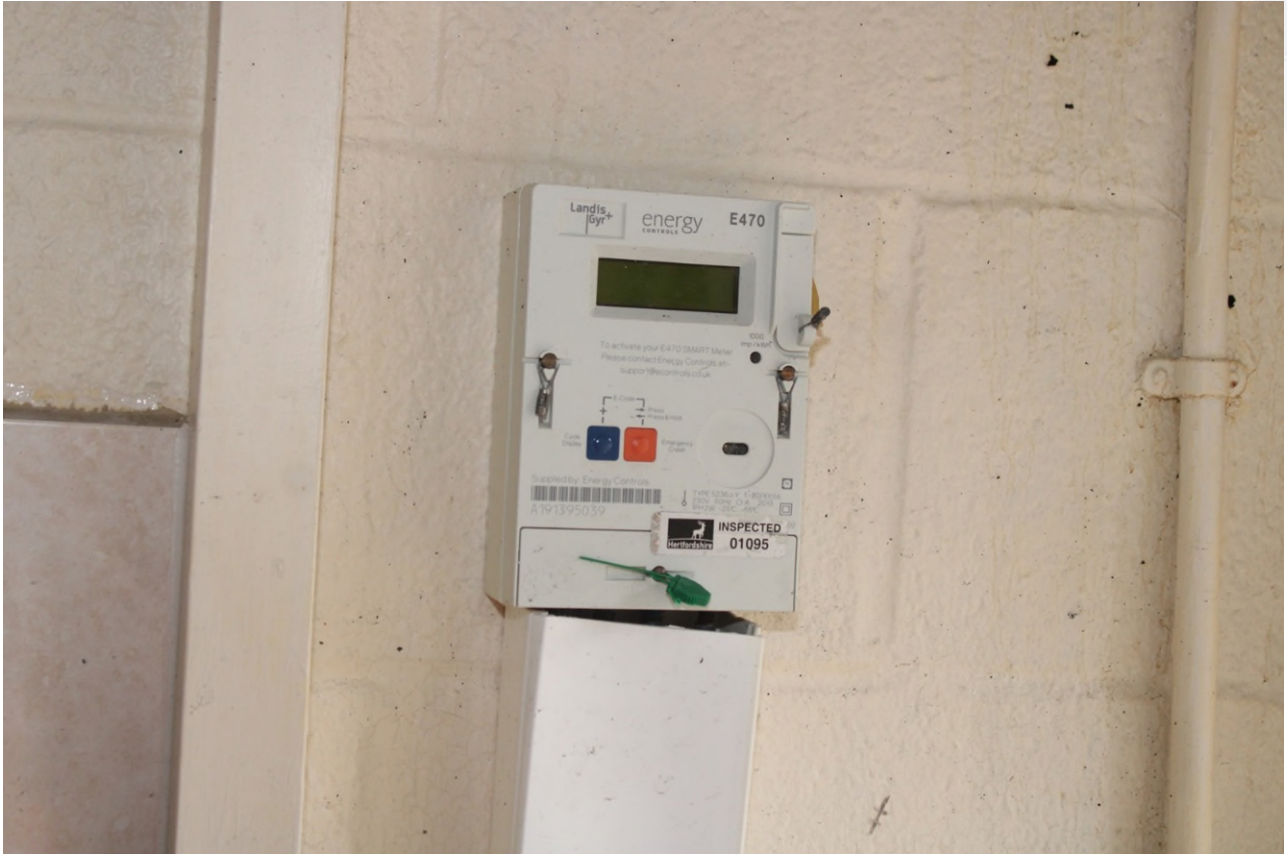
**Photograph 10:**

The electricity meter inside the sanitation unit for plot 9. The meter tails are in a plastic conduit beneath the meter.

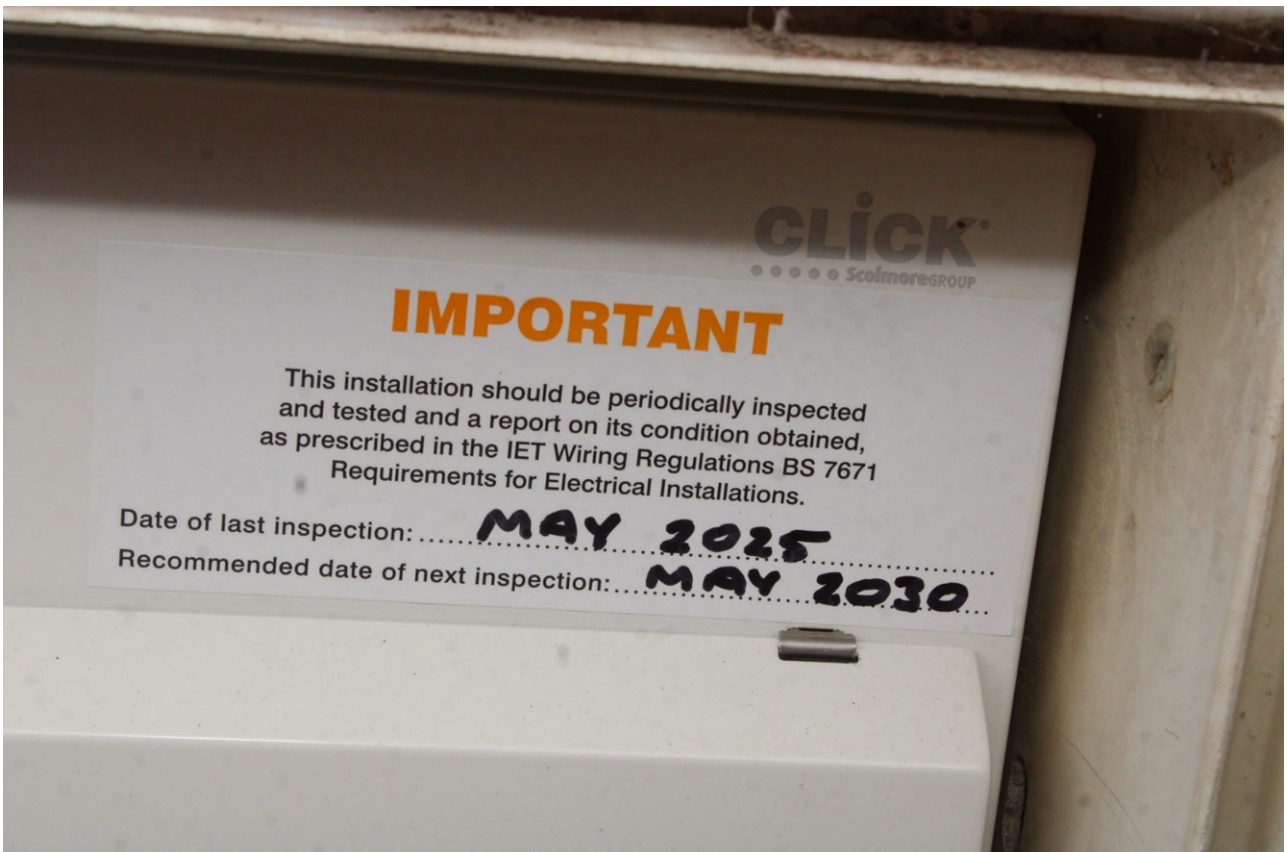
**Photograph 11:**

The label on the consumer unit serving plot 9 indicating that it was last inspected in May 2025.

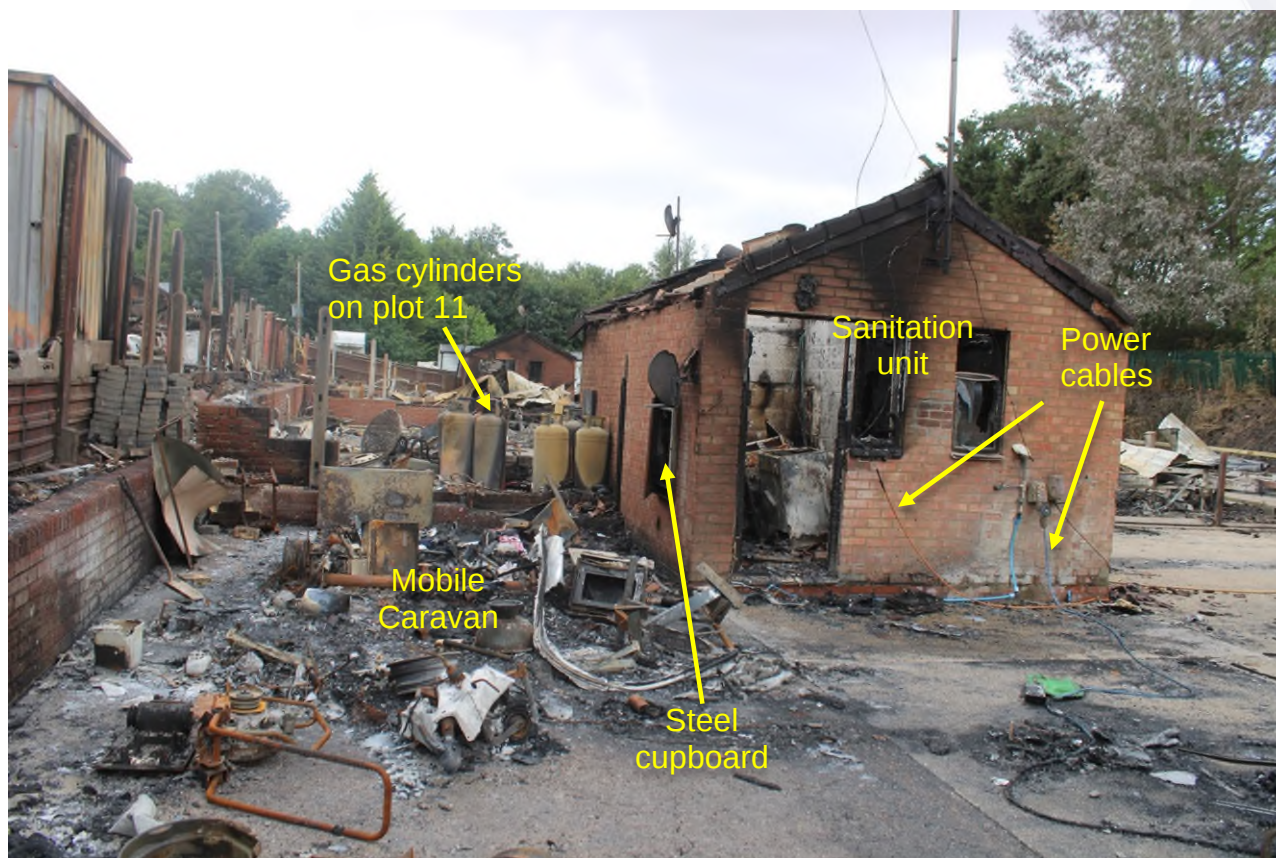
**Photograph 12:**

The mobile caravan on plot 10 (left) which was alongside the sanitation unit (right).

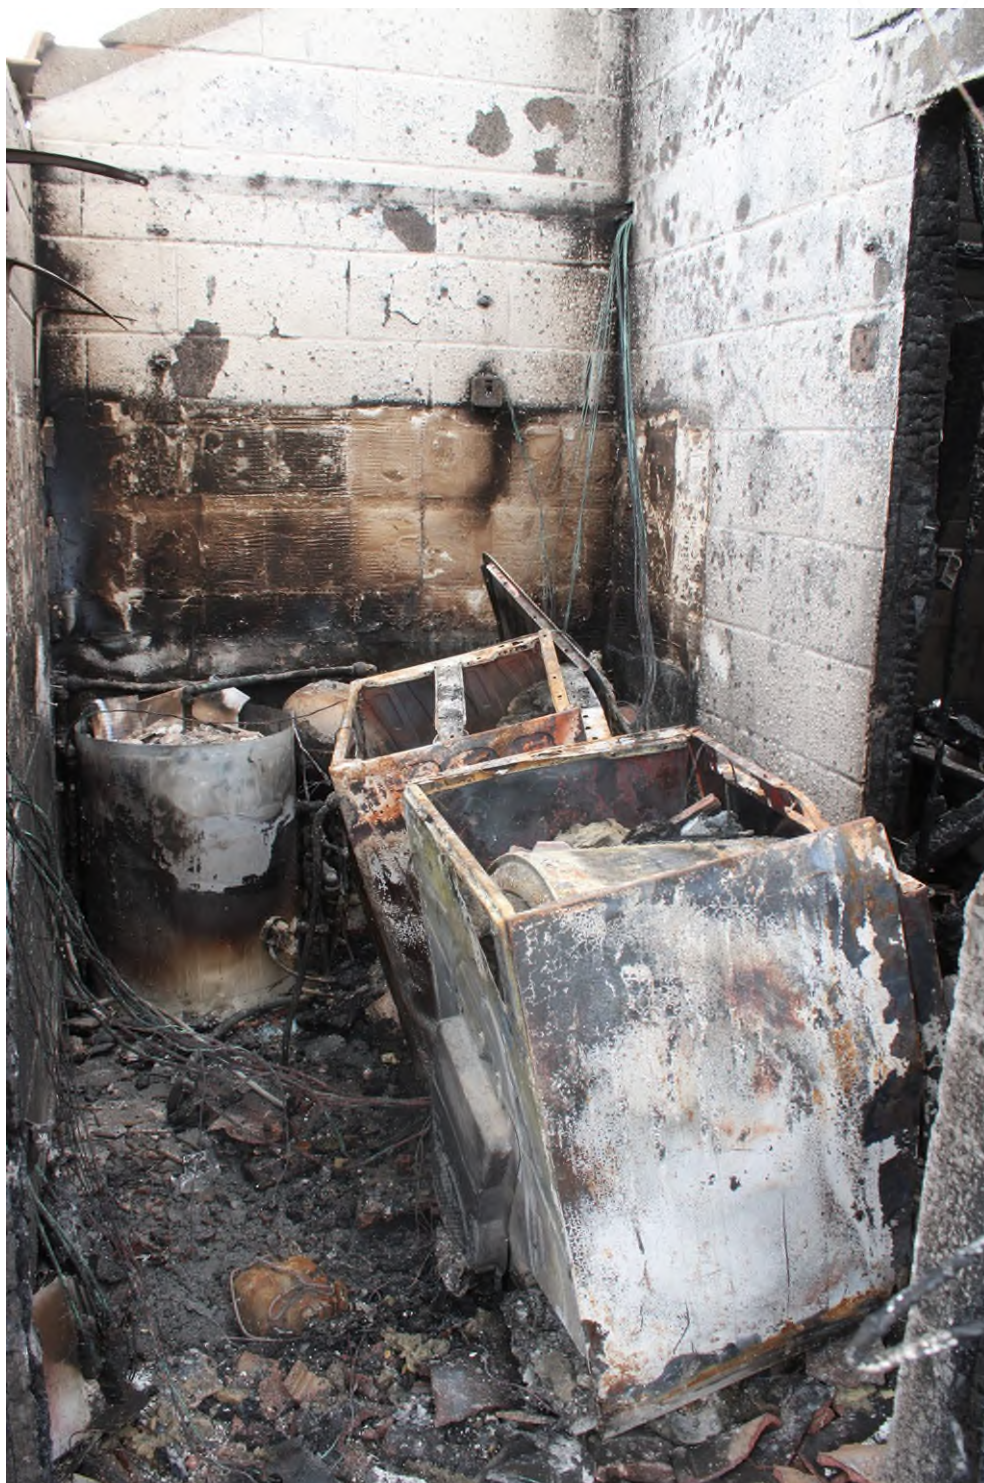
The interior of the sanitation unit was very severely fire damaged, with little combustible material remaining (see photograph 13). Many of the cables forming the fixed wiring inside the building had been destroyed and/or had fragmented as a result of exposure to heat from the fire. There was no evidence of any electrical arcing damage at the limited internal wiring that remained intact. The electricity meter, which had been attached to the wall of the sanitation unit, was largely destroyed, but there was no evidence of any localised heating at the meter terminations (see

**Photograph 13:**  
A view of the inside of the sanitation unit serving plot 10.

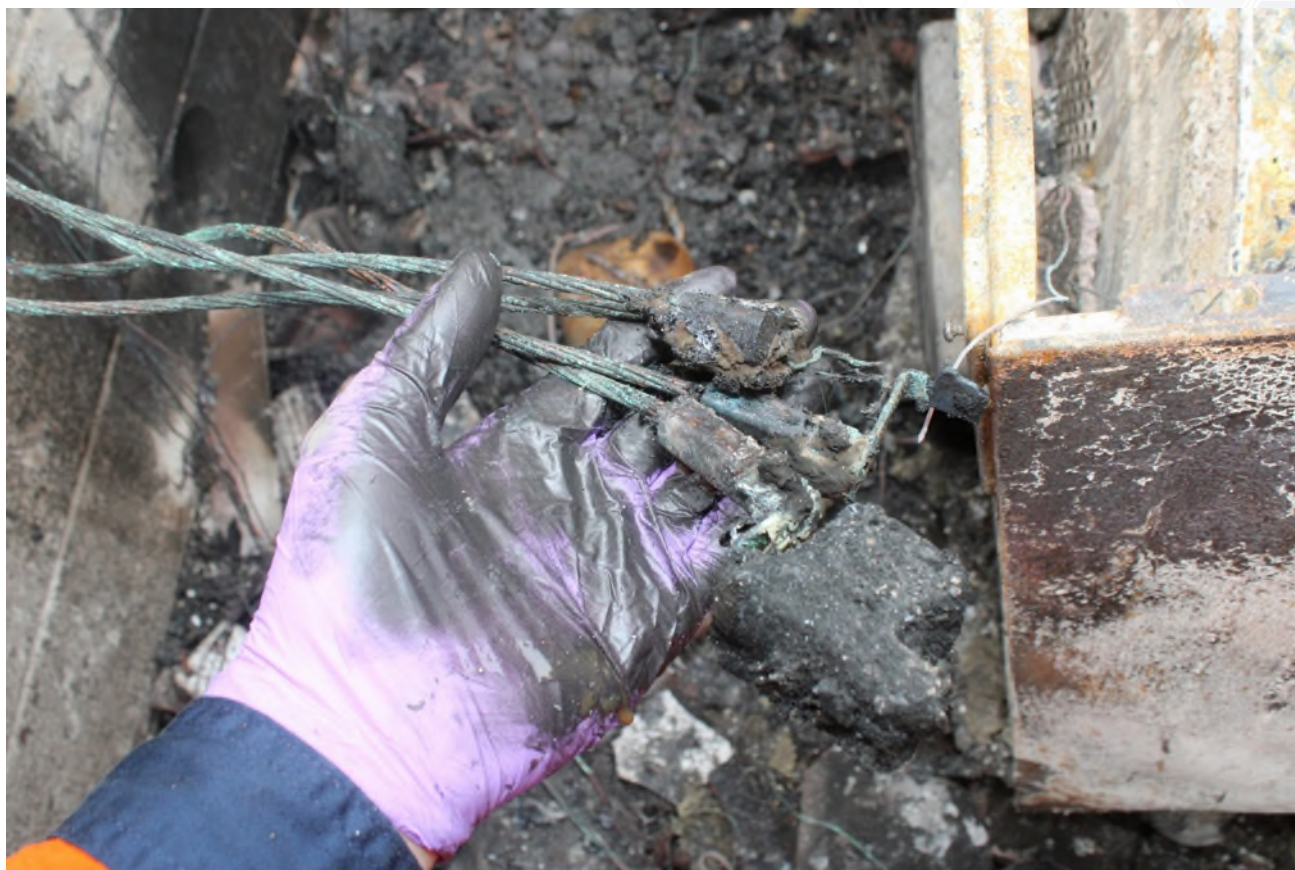
photograph 14), and no sign of electrical arcing damage at the tails where they were routed within the sanitation unit.

**Photograph 14:**  
The remains of the electricity meter, inside the sanitation unit.

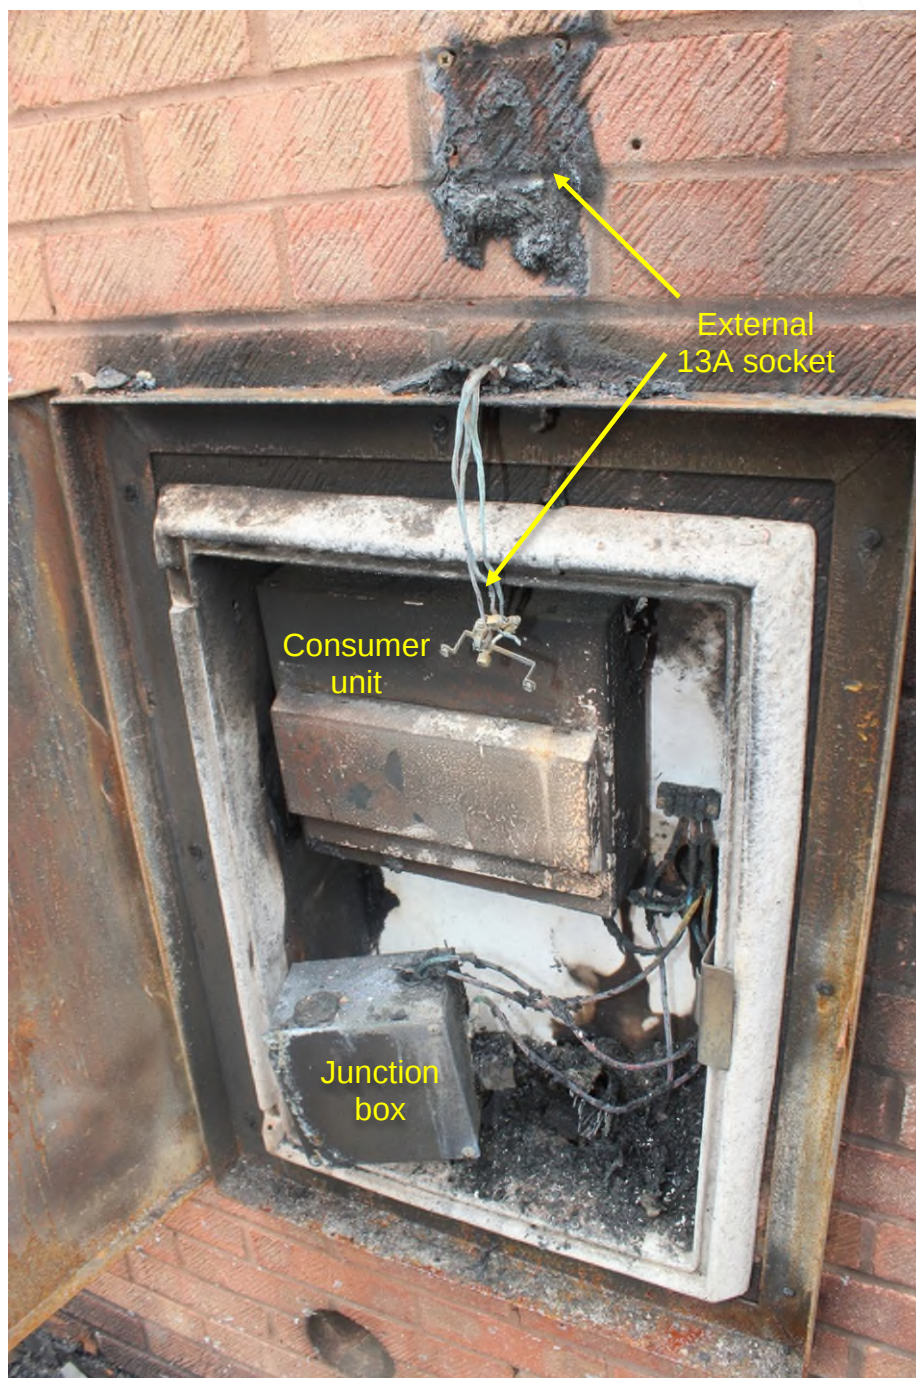
**Photograph 15:**

Above the external cupboard there was an external 13 A socket which was completely destroyed (see photograph 15). There was no suggestion (during the scene inspection or in the Police photographs) that anything was plugged into the socket, there was no remains of any plug pins on the ground beneath the socket, and no sign of a cable trailed from the mobile caravan towards the socket.

With regard to a fire starting inside the external cupboard, there was no evidence of a causative fault at the junction box and the consumer unit within the cupboard. These items were complete

(i.e. none of the components were missing), and the damage to these items can be accounted for by external fire attack. Accordingly, the equipment in the external cupboard, which may have been the responsibility of Hertfordshire County Council, can be ruled out as a cause of this fire.

A view of the equipment inside the steel cupboard on the external face of the sanitation unit wall.

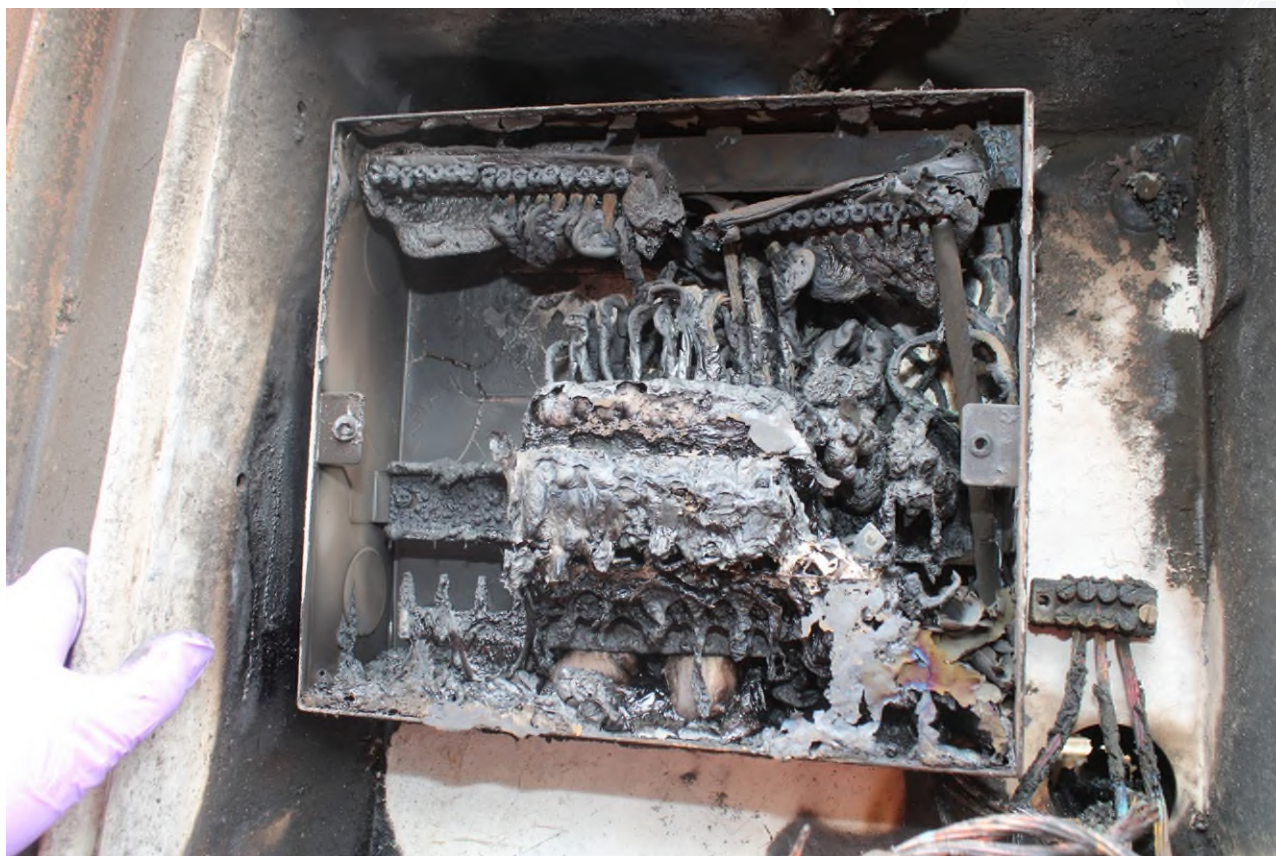
**Photograph 16:**  
A view of the remaining plastic inside the consumer unit.

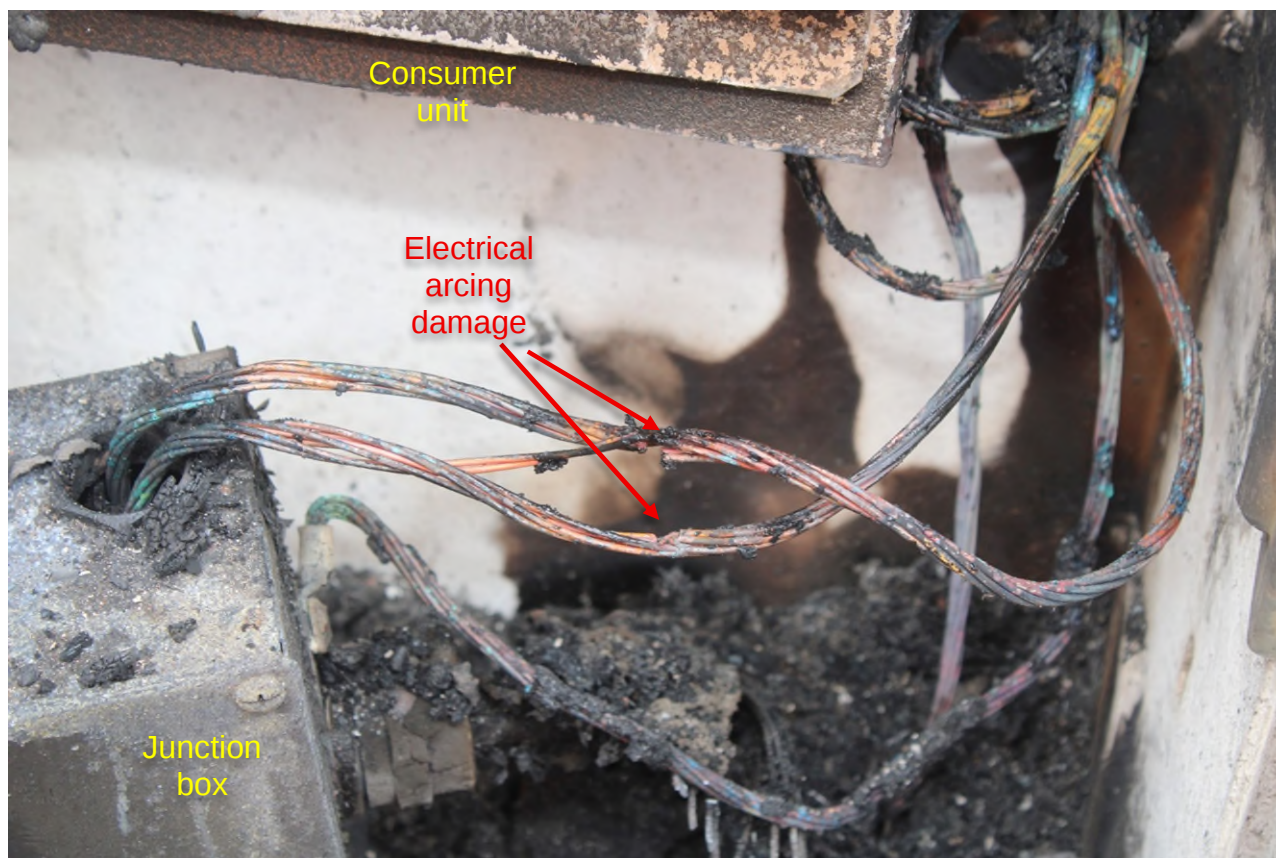
There was no remaining pattern of damage to the caravan park to indicate the area of origin of this fire. However, electrical arcing damage, such as that found on the meter tails inside the steel cupboard on the outside of the sanitation unit, can provide evidence for the area of origin of a fire. In this regard, in general during a fire, electrical arcing damage occurs when the electrical insulation of a cable is destroyed by the developing fire. Once the insulation is destroyed, electrical conductors at different electrical potentials can come into contact, leading to a short circuit fault and localised melting (electrical arcing damage) at the point of contact between the conductors. The short circuit fault current typically results in the operation of the electrical protection (usually a fuse or a circuit breaker) protecting the cable. Once the protection has operated (blown / tripped) the cable is electrically isolated and no further electrical arcing can occur. Accordingly, electrical arcing damage can indicate where a cable was first attacked by a fire.

In this case the electrical arcing damage had occurred at meter tails within the external steel cupboard, rather than inside the sanitation unit close to the meter. The short circuit fault current had likely resulted in the operation of a 60 A circuit breaker at the main distribution board in the warden's building. This evidence indicates that the external meter cupboard was subject to fire attack or radiant heat before a fire developed within the sanitation unit. This is most readily explained by either a fire developing within the external cupboard, or a fire at or in the area of the mobile caravan.

**Photograph 17:**  
A view of the electrical arcing damage a short distance from the junction box.
