## REPORT CONCERNING THE CAUSE AND CIRCUMSTANCES OF THE FIRE AT VER MEADOWS CARAVAN PARK, REDBOURN, AL3 7RQ ON 12 JULY 2025

HERTFORDSHIRE COUNTY COUNCIL

FILE REFERENCE: 720086

1 AUGUST 2025

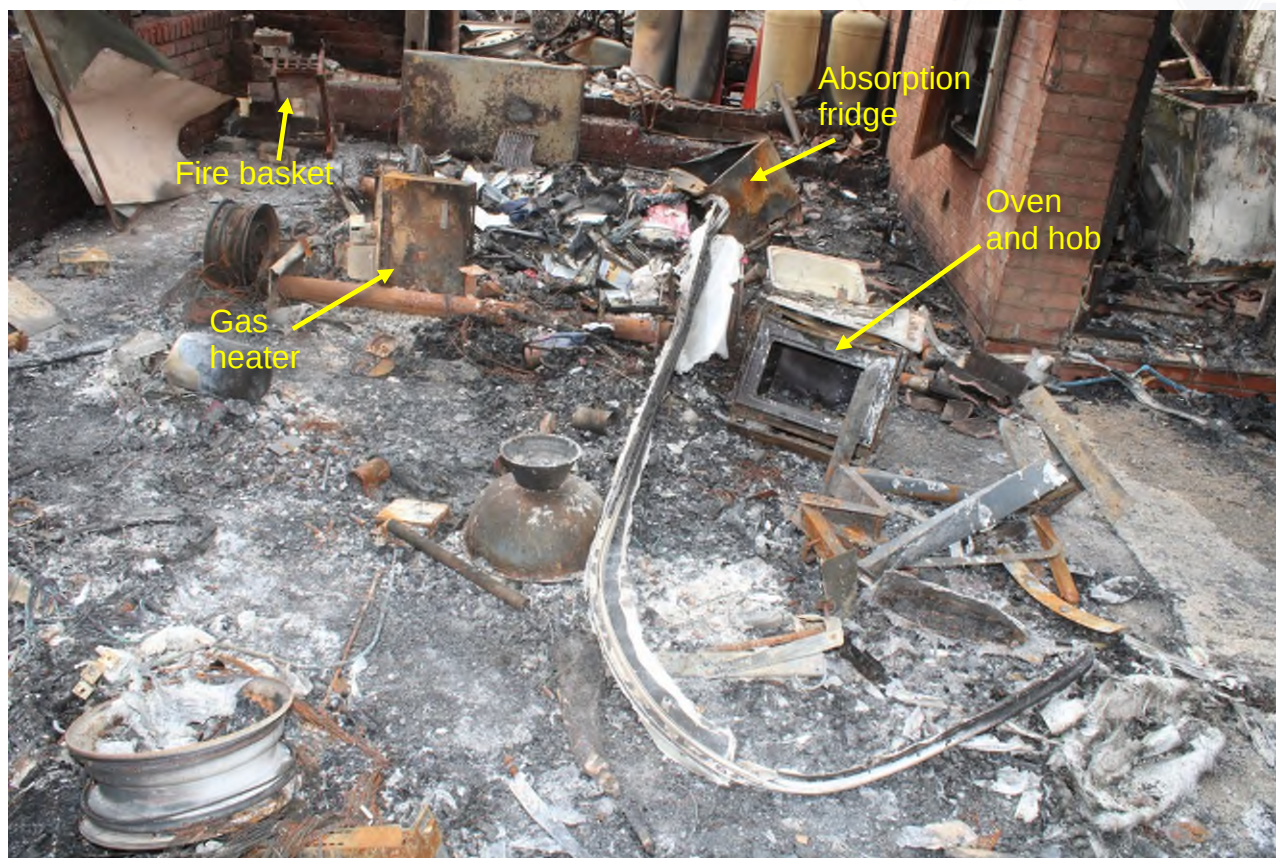
**Photograph 18:**

Appliances in the mobile caravan included an absorption fridge, a conventional electric fridge or freezer, a gas oven and hob, and a gas heater (see photograph 18). All the appliances had sustained very severe fire damage and, in general, they yielded no useful evidence. However, the oven did not appear to contain any food at the time of the fire (although given the extent of the damage, any such evidence may have been lost) and the controls for the hob rings all appeared to be in the same position, which was presumably *off*. Moreover, on the basis of the absence of any power or gas supply lines being routed to the caravan, none of the appliances were powered/fuelled at the material time.

A view of a selection of the appliances in the mobile caravan.
